**NORTH AUGUSTA  
WATER QUALITY & STREAM ASSESSMENT 2007 to 2020**

**April 2021**

This report was prepared by  
Tanya Strickland, Stormwater Superintendent  
Michaela Canady, Editor  
City of North Augusta, Stormwater Management Department

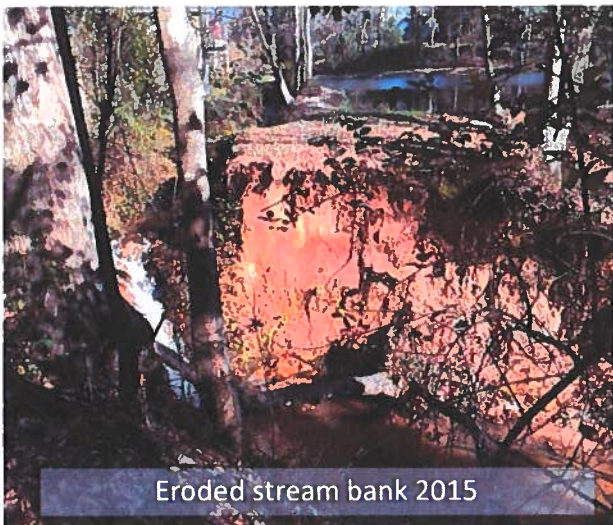
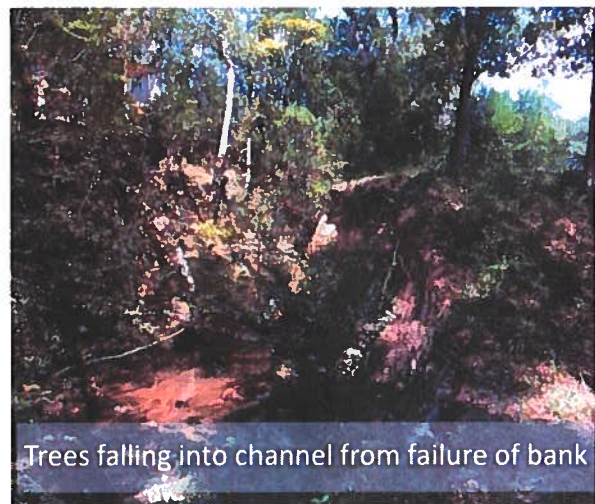
Below this area, the integrity of the stream channel is mostly failing (from Buena Vista through to the Savannah River). Considerable rain events have made the problem worse over the past few years. Channel integrity is failing from the end of the reach next to Crystal Lake Pond and below. The pictures here show some of the issues at and below Alta Vista Avenue. The upper reaches appear meandering, wide and braided in some areas. With the exception of the ravine above the Mokateen/Jackson pond.

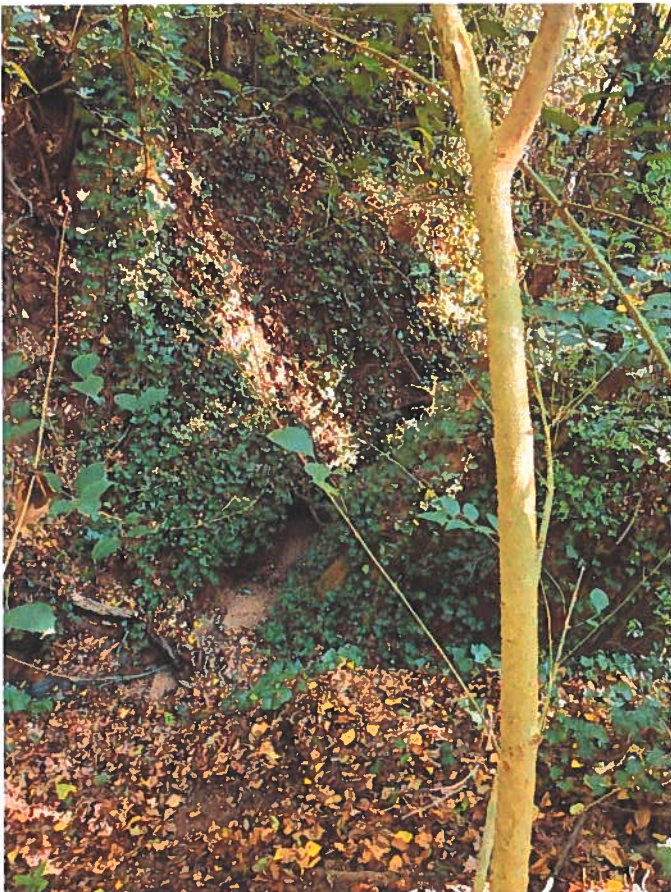
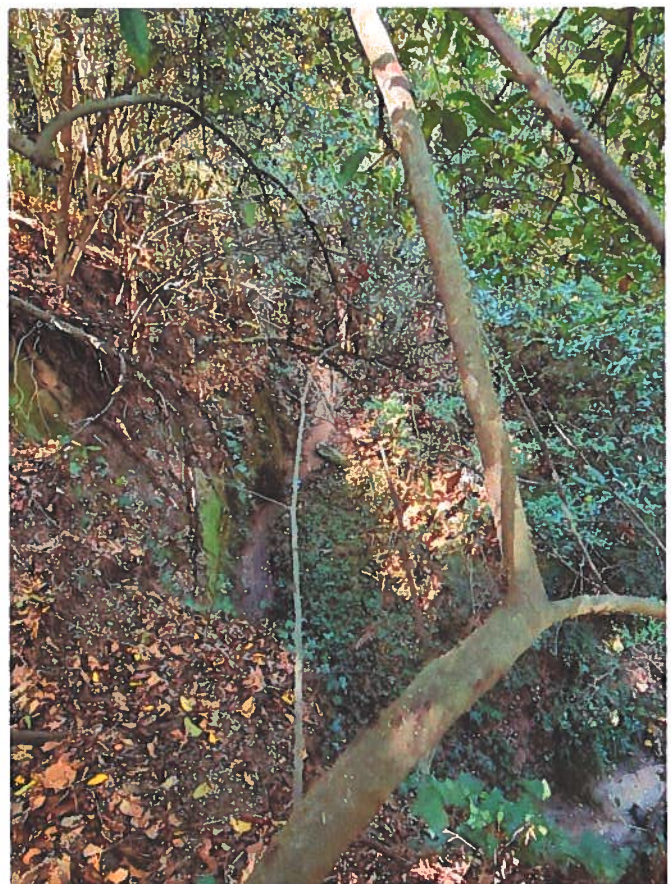
Overall, the channels within the basin are in poor shape. The lower reach of the basin has shown signs of stress with degrading channels and excessive debris collection within them. Eroding banks have increased channel size and created unstable banks. Ditches located within the basin appear to be failing. Many have been lined with concrete or rock and cement, but that has not held up in many over time. There have been incidents reported of property damage from the eroding conveyances that have become larger due to the excessive flows during heavy rainfalls. As mentioned earlier, easements for many of these features are not established and individual property owners must maintain them. Existing pipes made from corrugated metal have failed within the basin as well. The city has repaired many of these over the past few years. More are slated for repair.

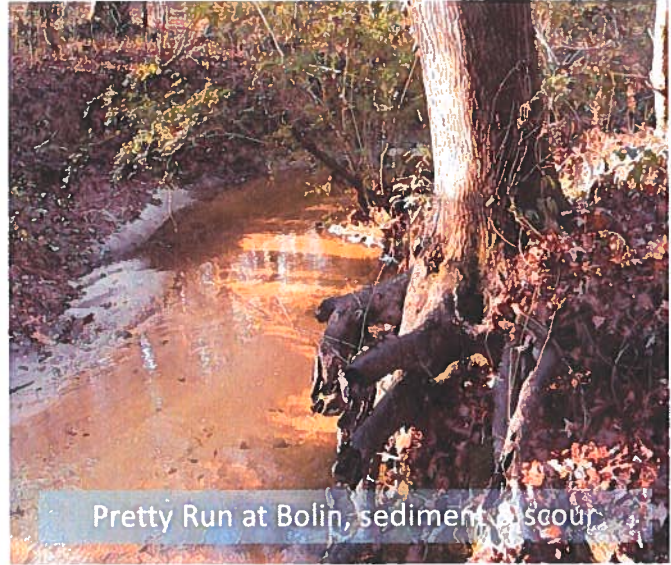
Pretty Run at Bolin, sediment & scour

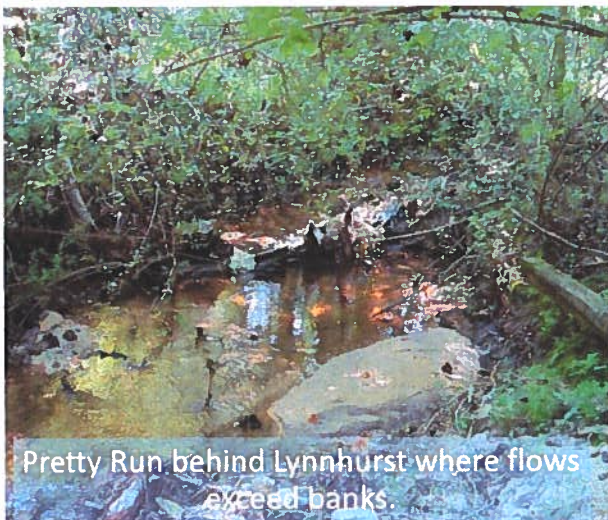
Pretty Run behind Lynnhurst where flows exceed banks.

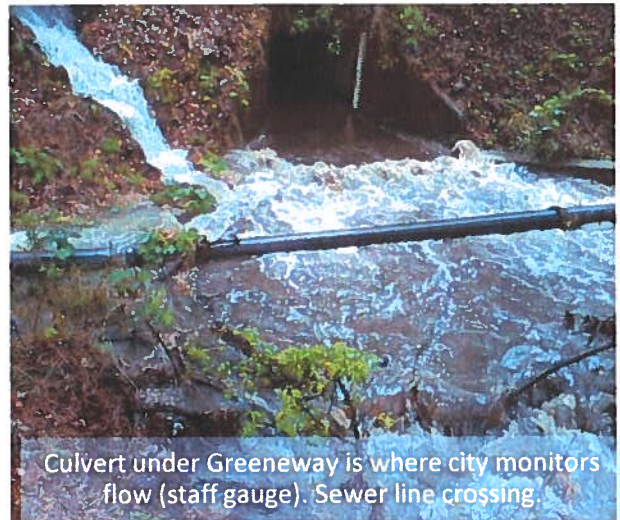
Culvert under Greenway is where city monitors flow (staff gauge). Sewer line crossing.

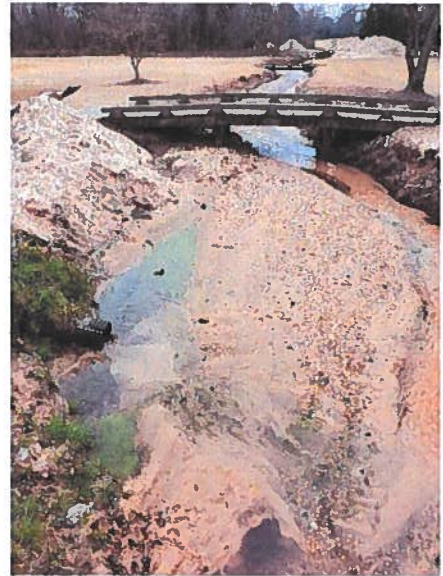
The basin has been affected by excessive flows. Channel integrity is degraded with erosion and incision occurring in channels within the entire basin. Newer developments within the upper basin flows through detention ponds to reduce the release rate. Older shopping centers development within that same area do not. Lowes, River Commons, Shoppes at North Augusta and Walmart are new projects that provided detention. Other older shopping areas on Martintown Road, Knox and along Atomic Road do not. The combination of unretained from these locations along with SCDOT roadways entering the same pipe infrastructure as the newer detained flows has the system at its maximum capacity. At the outfalls of the system, it is obvious there is a problem. The flow is creating deep ravines, failing slopes on channels, sediment loads within the channels, impacted storm system and sanitary infrastructure, and flooding.

In addition to storm conveyances failing, stormwater pipes in streets have failed, ponds have failed, and commercial infrastructure has failed in the area. The city has relined many feet of pipes that were causing road failure in Woodlawn Place over the past few years. A pond and its piping failed adjacent to that location from a condominium complex. An additional failure occurred along the length of the entire complex at one apartment complex. These failures have also impacted existing infrastructure downstream.

This area would benefit from a comprehensive review to identify areas where regional detention could be accomplished. Unfortunately, there is not a lot of available locations for that to work. For this reason, all redevelopment within this area on larger tracts that don't currently provide some sort of detention, should consider it. The city must consider this as well, and work toward processing development proposals within the basin that will not create more problems, but could solve existing ones.

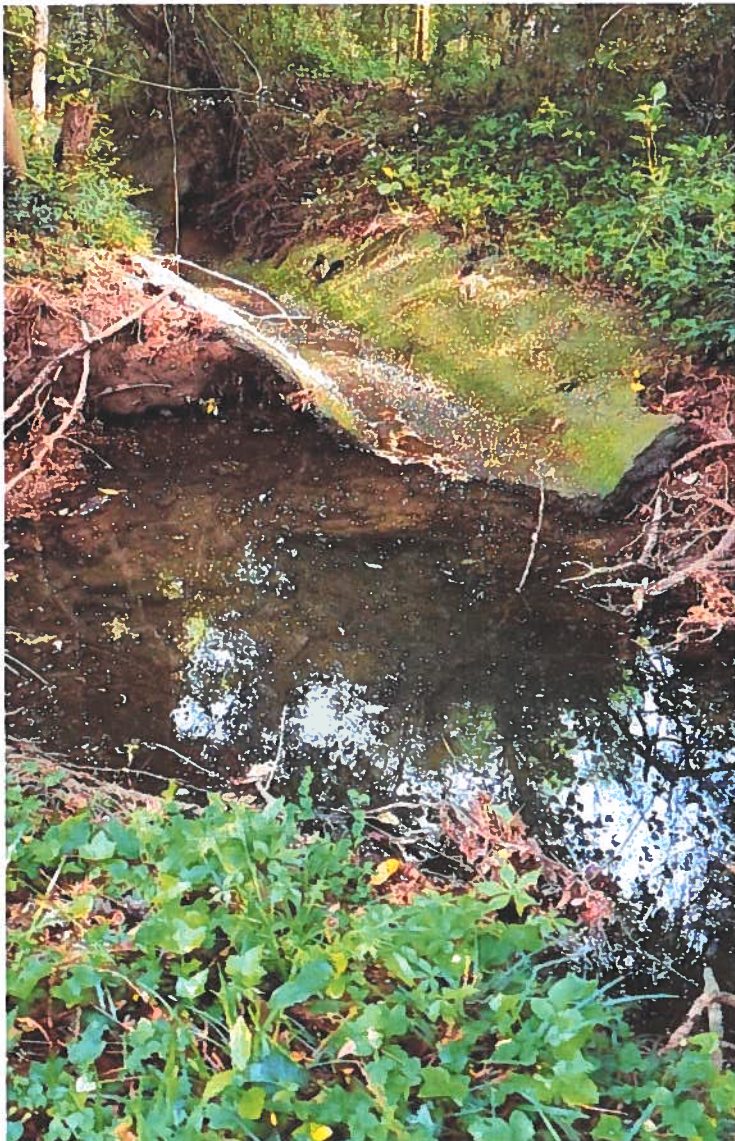
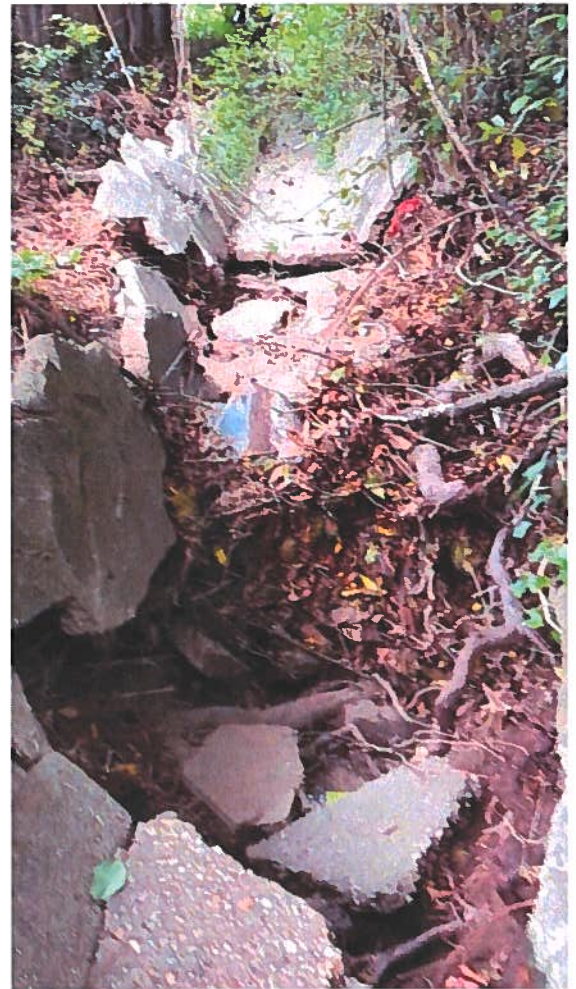
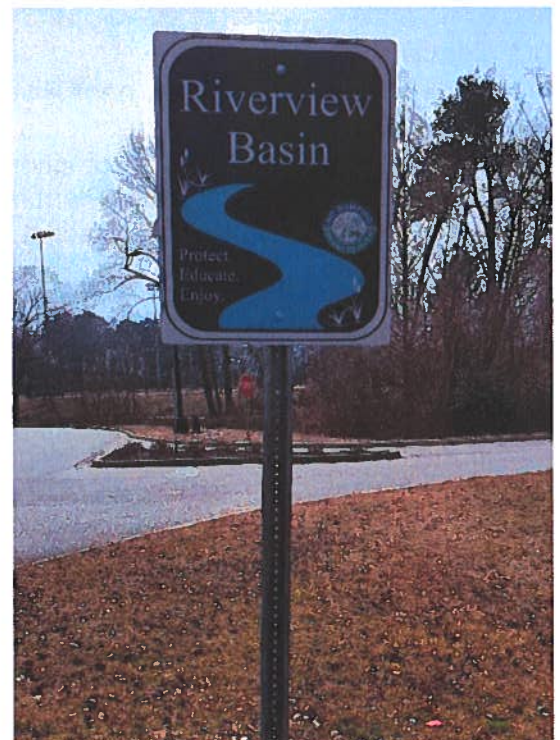
The stream channel that takes flow to the Savannah River within this basin is in fair condition. As it leaves the residential area, wetlands and wooded areas protect the stream channel. It is shaded and shallow. Once it passes through the Riverview Park, there are areas where excessive erosion is occurring. A disc golf course traverses this reach and some of the infrastructure for the course is causing problems during excessive rain events. The city is working with the Disc Golf managers to resolve these issues. An area of preservation for the endangered relict trillium is located along the lower reach of the basin below the City of North Augusta Water Plant water tank.
