STORMWATER MANAGEMENT

NORTH AUGUSTA STREAM WATER QUALITY BASELINE ASSESSMENT

June 2007

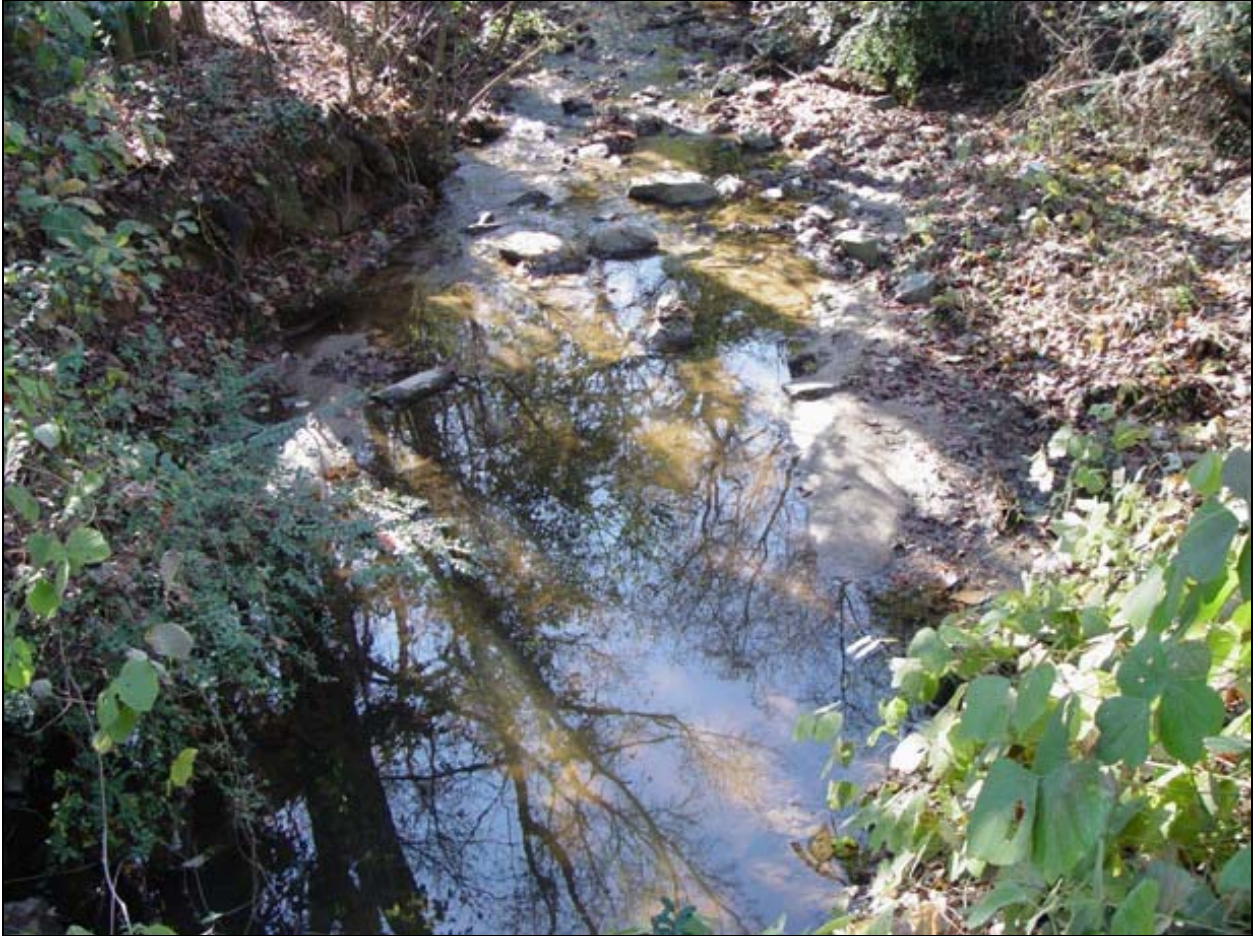
Crystal Lake Basin

The Crystal Lake basin perennial stream, (Crystal Creek) is routinely inundated with stormwater flows that exceed its capacity. Upstream locations are filled with debris and trash including cans, bottles, toys, tires, and grocery carts. Storm events move debris down the channel and most of it is captured on the upstream side of Buena Vista Avenue. Some sewer service lines cross the creek and have been found broken in the

The preliminary physical stream assessments at Crystal Creek indicate that this stream channel is currently not effective at transporting loads of stormwater during heavy storm events. The three assessments that were conducted along the stream channel resulted in poor condition ratings, with each scoring less than 6.0. Channel erosion is evident, trash and debris are present, and the banks frequently overtop in some locations during heavy storms. In addition, flooding has been reported and observed at the lower reaches of the channel and ponds located in the system have overflowed their banks on occasion (Crystal Lake). Sediment deposition at the final reach of the channel is evident, and the channel near Hammond's Ferry is cutting deeper. Sediment is being deposited at the river's edge, creating a sand-bar effect. Channel widening and deepening is ongoing.

This area of the city would benefit from low impact development (LID) on future projects. LID techniques that would be beneficial could include rain gardens, collection and reuse of stormwater, and pervious parking areas. A current project under development, the Oak Leaf Condominiums, is utilizing an underground stormwater detention and filtering system. In addition, the city retrofitted and repaired a failing storm sewer system at a road crossing in the lower reaches of the system. This has improved the transport of stormwater and eliminated the flooding that recently occurred in that location. The city is looking at additional ways to improve the channel conditions and is working with local stakeholders to implement new best management practices (BMPs) to decrease the possibility of flooding and overtopping of ponds in the system.

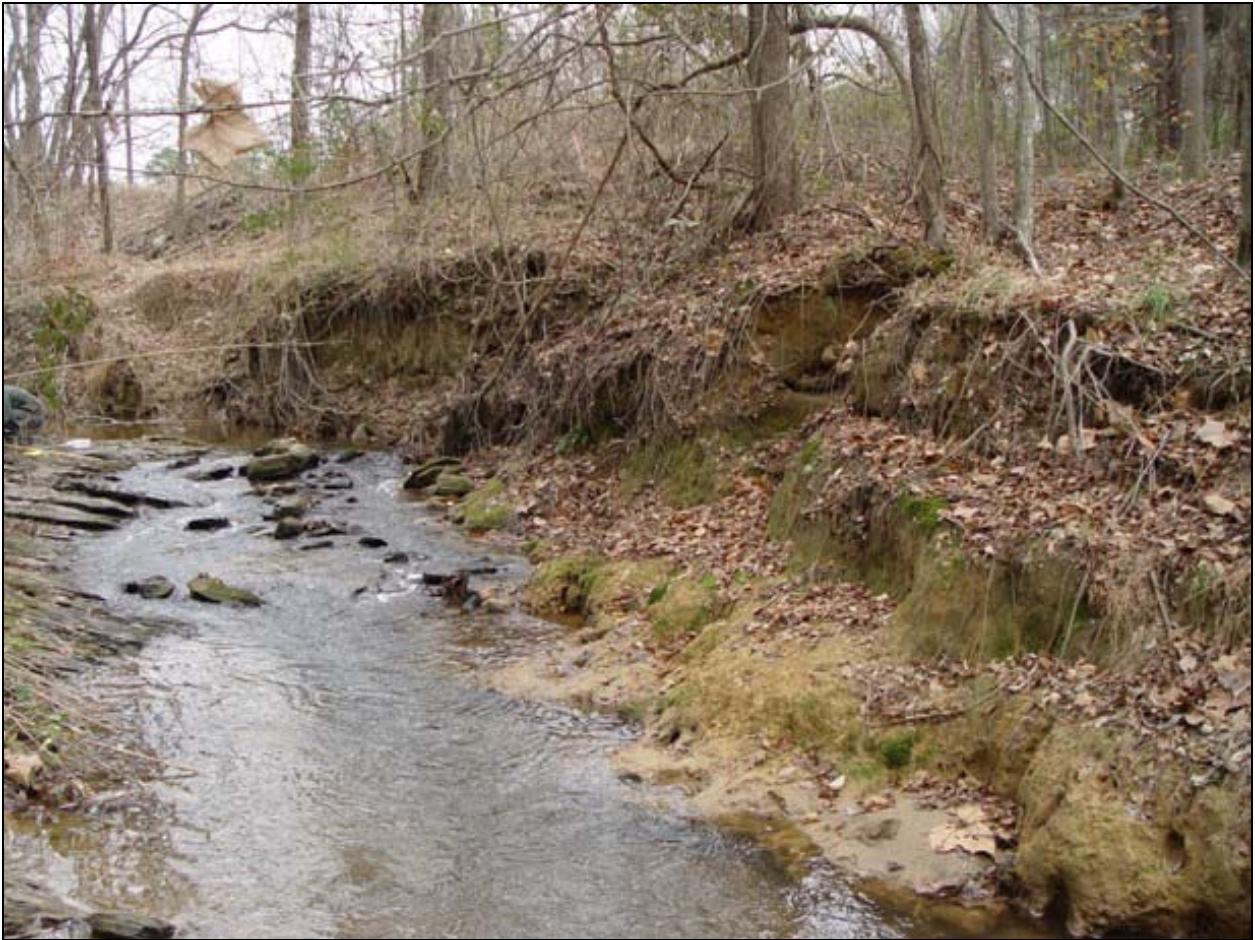
Pole Branch Basin

Pole Branch basin is the largest basin in North Augusta. It receives water from a large part of the city along with a large portion of non-city residential and commercially developed land in Belvedere, SC. The preliminary physical stream assessments at Pole Branch indicate that this stream channel is currently not effective at transporting current loads of stormwater during heavy storm events. The two assessments that were conducted along the stream channel resulted in fair and poor conditions scoring less than 6.0 and just above at 6.3. Channel erosion is evident and the banks frequently overtop in some locations during heavy storms. In addition, bank flooding has been reported and observed at the lower reaches of the channel below Bergen Road. Sediment deposition and bank instability is evident causing hydrologic alteration and channel widening.

Currently the lower reaches of the basin are showing signs of stress. Failing banks and sediment deposition is increasing in near Willow Wick apartments and beyond. The banks are falling into the channel during large rain events at and below the sample location at Bergen Road. Tributaries that feed Pole Branch along Knobcone Avenue are deeply incised and crossings under Knobcone are failing. Future development in this area is planned in the next two years. The basin needs to be studied further and there is a need for more physical stream segment assessments throughout the basin.

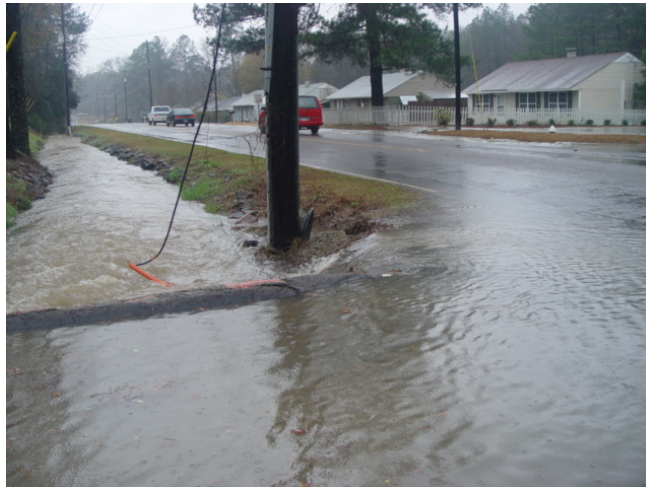
Figure 2: 2007- Flooding at Buena Vista and Mealing Avenue

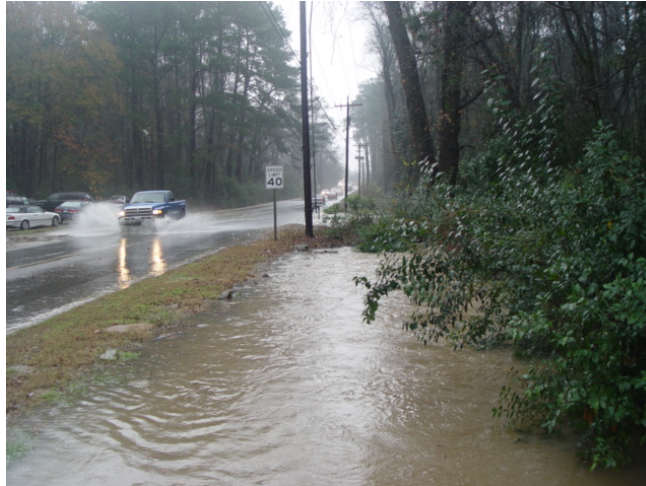
Figure 3: 2007 - Flooding at Buena Vista near Blockers' Barber Shop
