**North
Augusta**  
South Carolina's Riverfront
STORMWATER MANAGEMENT

**NORTH AUGUSTA
WATER QUALITY & STREAM ASSESSMENT 2007 to 2020**

April 2021

This report was prepared by
Tanya Strickland, Stormwater Superintendent
Michaela Canady, Editor
City of North Augusta, Stormwater Management Department

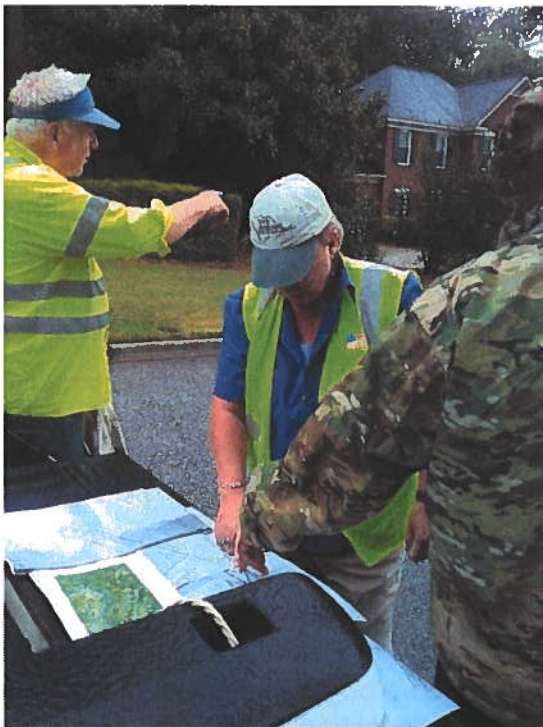
The Streets & Drains and Stormwater Management Department Staff are using the priority map to assign work tasks within the city. All Priority 1 basin infrastructures are inspected, repaired or cleaned annually. **Priority 2 & 3** basins will all be inspected & maintained in the same manner during the first round of assessments to verify 100% of the system is mapped accurately, and or in need of repair. After that, these basins will undergo the same process but on a rotational basis, Priority 2 biannually and Priority 3 basins as needed, or if a citizen reports issues.

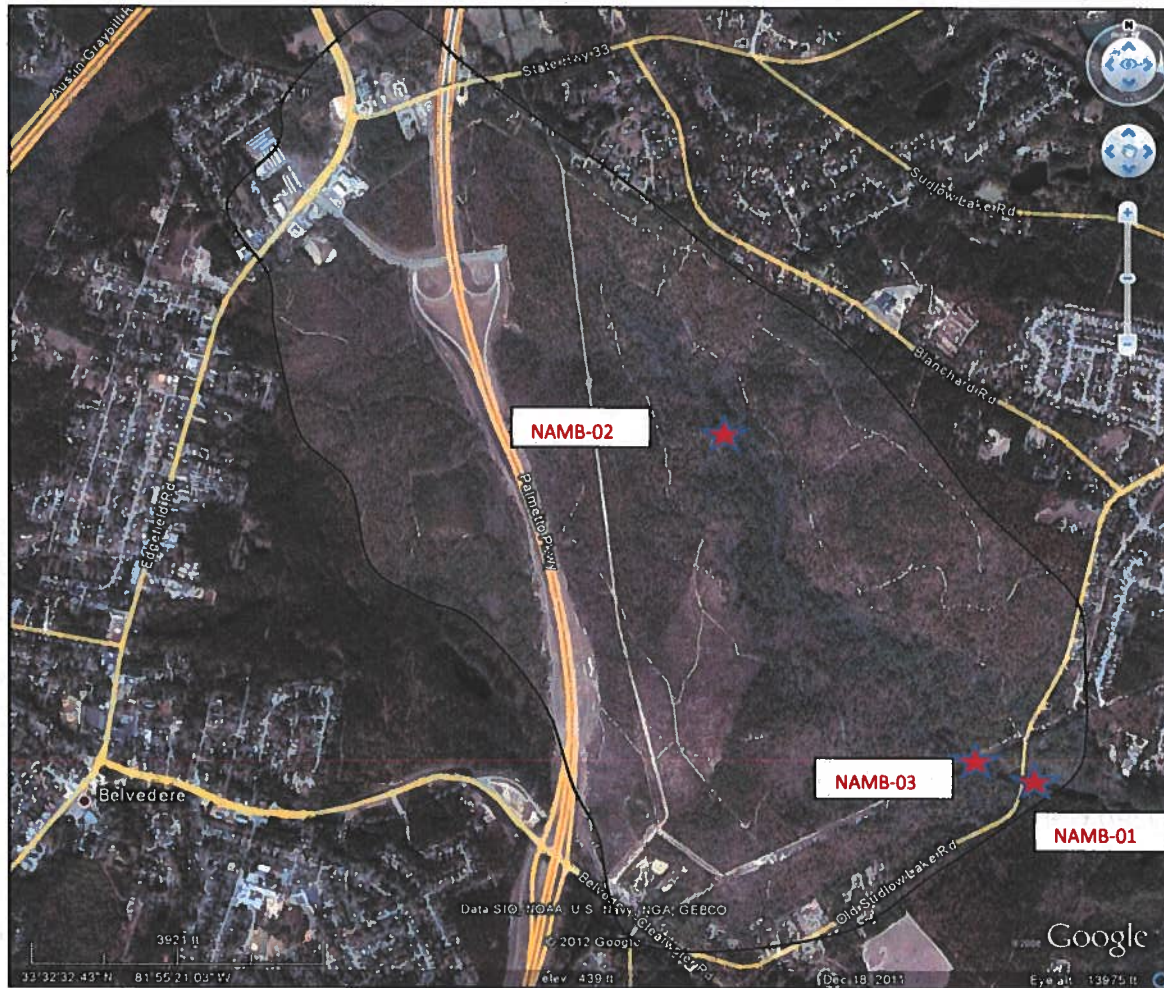
3.0 Mims Branch Basin

The Mims Branch basin drains a large undeveloped basin (1,595 acres) located off of Highway 25 from Ascauga Lake Road to Blanchard Road and is bordered by Old Sudlow Lake Road. It is the only basin in the city that is nearly completely undeveloped. It is a Priority 1 basin. The preliminary physical stream assessments at Mims Branch indicated that it is a healthy stream channel that effectively transports the current load of stormwater. Each segment assessed scored higher than other streams in the city. There have been little changes to that condition.

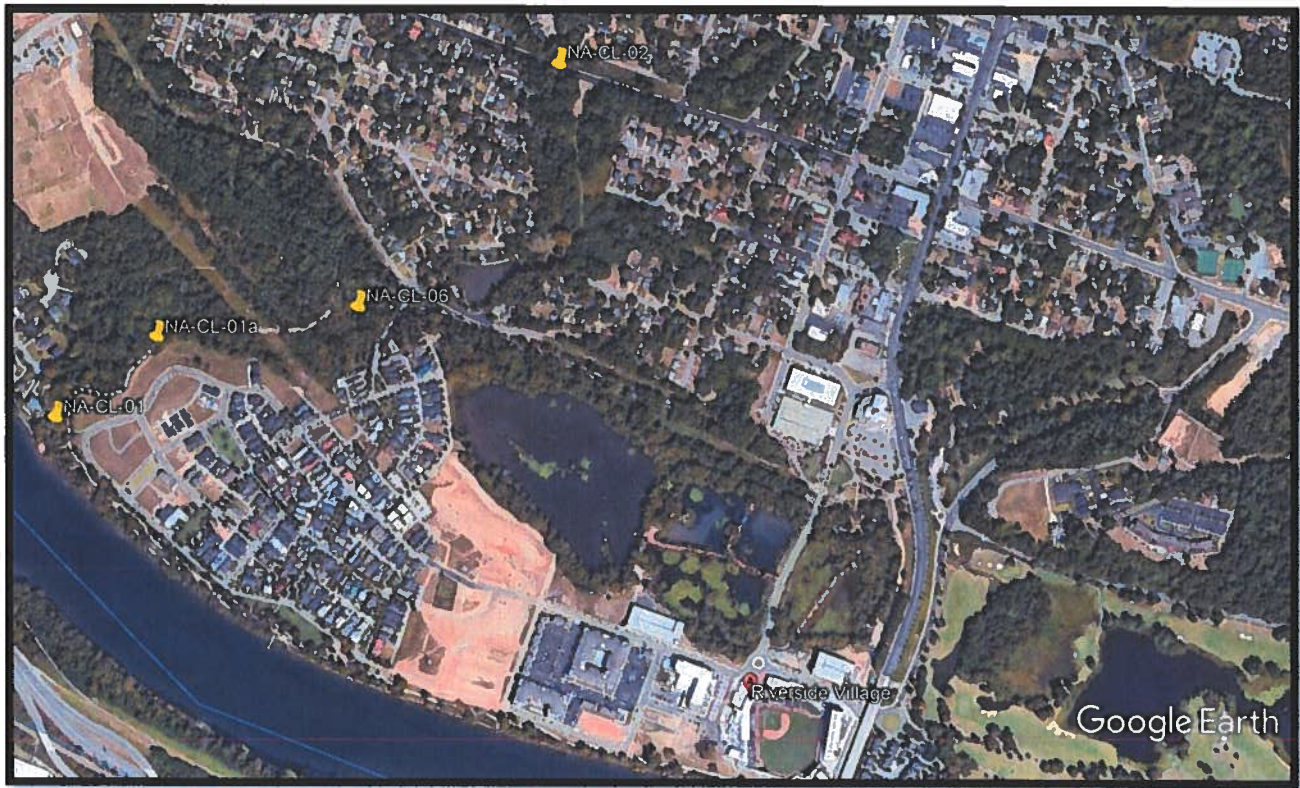
4.0 Crystal Lake Basin

The Crystal Lake basin is a smaller basin (564 acres) within the older sections of North Augusta. This is a Priority 1 basin. The basin drainage areas are actually depicted on the original Boeckh Plat as undeveloped wooded areas for drainage. These features have not changed much since that publication. The city has purchased several of the tracts shown on the plat to maintain the original drainage features. The Crystal Lake basin's primary perennial stream is called Crystal Creek (unofficially). A second drainage way within the basin transports stormwater through the storm system as it flows down the Georgia & Bluff Avenues to Brick Pond Park.

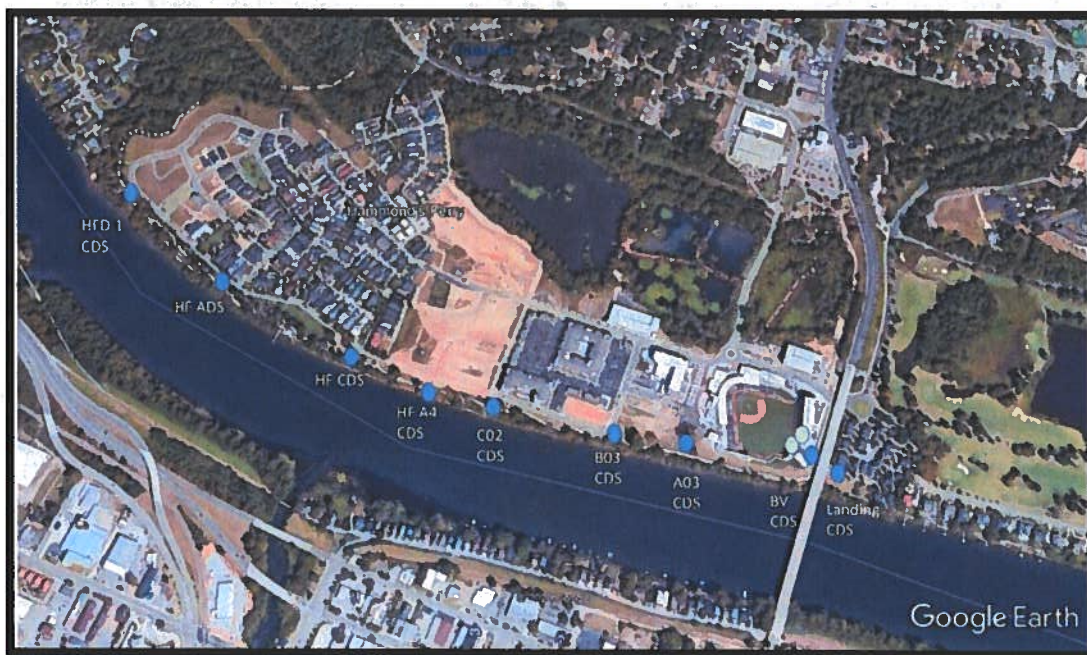
Figure: 4.1 North Augusta Riverfront development underground stormwater treatment unit locations.

Newer projects require a water quality treatment features. This includes the Brick Pond Park stormwater treatment system for the upper reaches of the basin and also underground treatment units have been added along the riverfront to capture and treat stormwater runoff to reduce pollutant loads entering the Savannah River from the riverfront development. Brick Pond Park treats stormwater from for projects located above Railroad Avenue. As for the development below Railroad Avenue, individual underground treatment units are installed at the final point in the stormwater system before water is discharged to the river (see Figure 4.1 below). Each blue dot is an individual treatment unit at the end of the stormwater system. The underground units' capture and collect sediment, oils and trash that enters the storm drains during storms.

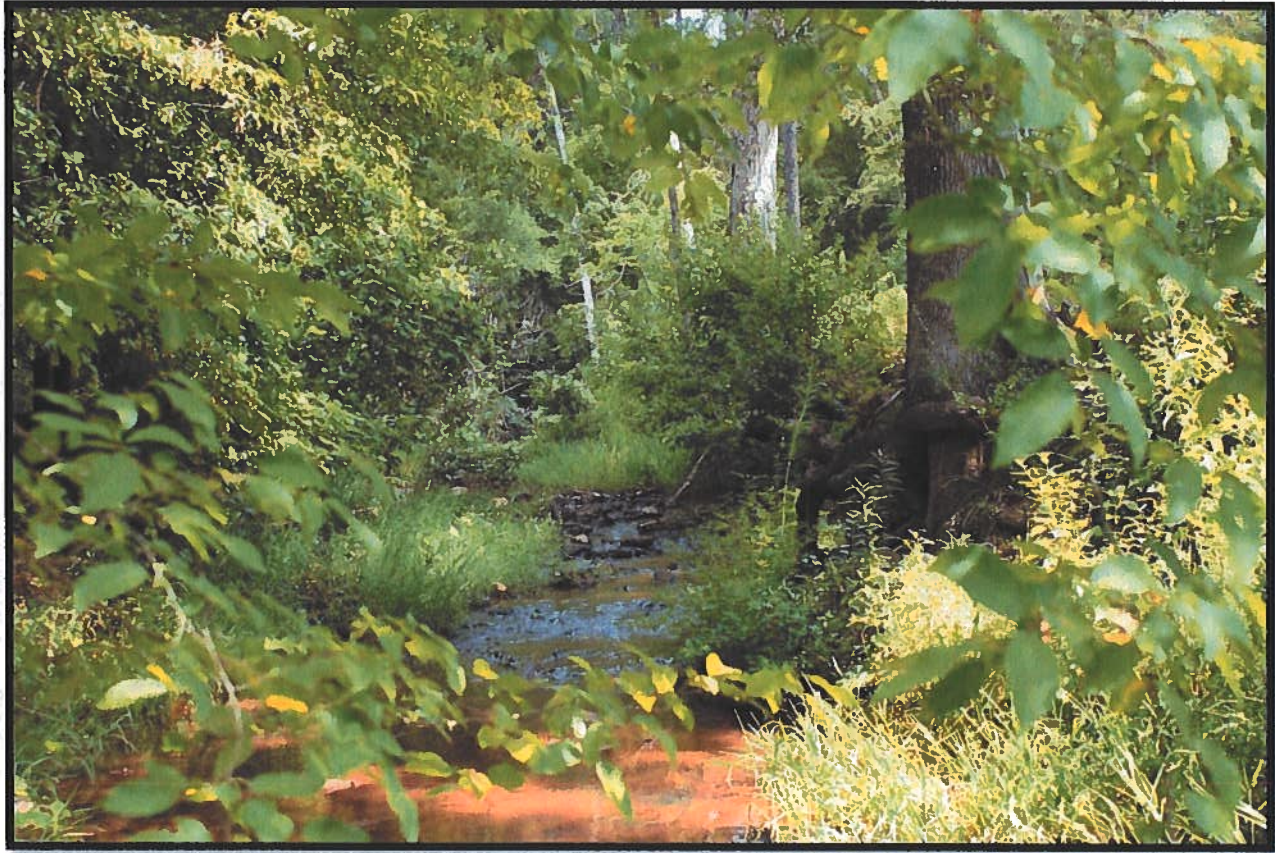
5.0 Fox Creek Basin

Fox Creek basin is a large 4,700-acre drainage area located at the edge of the city near the Edgefield County line. This is a priority 2 basin. It is mostly still wooded (approximately 71%) with creeks and streams that flow into Gregory Lake located on Gregory Lake Road and into smaller tributaries below it, all that are part of the Fox Creek Basin. The basin is located within the source water protection area of North Augusta. The city annexed over 500 acres within this basin over the past few years due to development requests or city purchases of the abandoned railway for North Augusta Greenway connectors and the North Augusta Country Club.

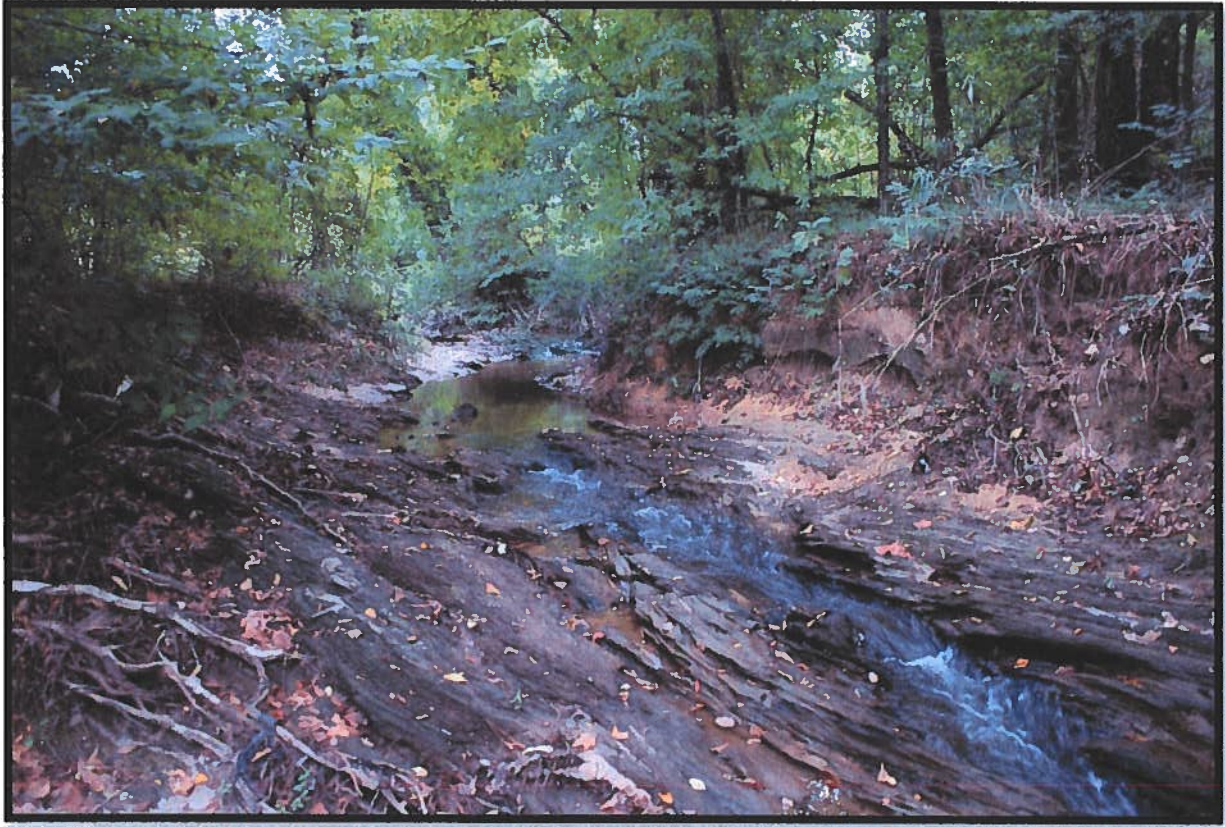
6.0 Pole Branch Basin

Pole Branch basin is one of the city's largest basins with 4,567 acres of drainage area. It is located within the city's source water protection area. The basin is under development pressure with approximately 76% of the basin developed to date (estimated). For these reasons it is a Priority 1 basin. To accommodate study of such a large basin, we look at it in two sections, the upper Pole Branch and the Lower Pole Branch areas. The upper basin borders along Highway 25 at I-20 to Arbor Place off of Walnut Lane and then encompasses Austin Heights and Bergen Road businesses and communities. The lower basin collects rainfall from Belvedere to Five Notch road at I-520 and also Knobcone Avenue. It includes a large area bordering Edgewood Heights Subdivision and the shops that border it at Highway 25 and areas near the North Augusta High School, Paul Knox Middle School through and along Five Notch Road leading to I-20. All creeks and streams located in the area converge into Pole Branch. The Upper Pole Branch crosses I-20 at Bergen Road and at Austin Graybill Road. Lower Pole Branch converges with Fox Creek just below Martintown Road and then the confluence stream empties to the Savannah River.

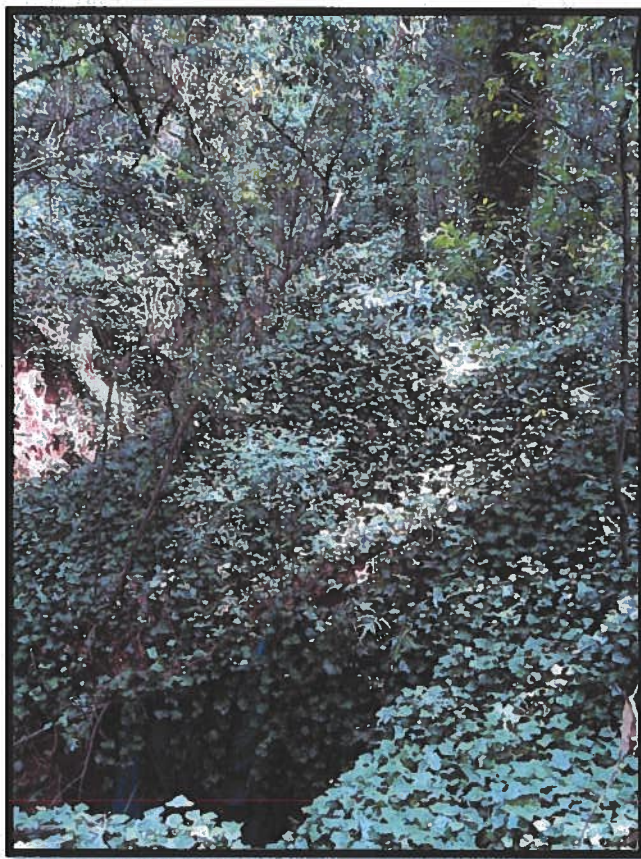
7.0 Hammond Hills Basin

The Hammond Hills basin is located in a residential neighborhood with some mixed use. The basin drainage area is 410 acres with 76% of that area developed. This is a Priority 1 basin. The infrastructure is older in this area with stormwater systems that consist of pipes and ditches. There is minimal stormwater piping in the basin, only where necessary to cross roadways. The original neighborhood was developed in the 1950s. This creates issues in areas that are not obvious. During development easements were not obtained for many of the ditches that are located there. The basin is sampled at two locations lower in the basin, prior to crossing into the final reach where they discharge to the Savannah River.

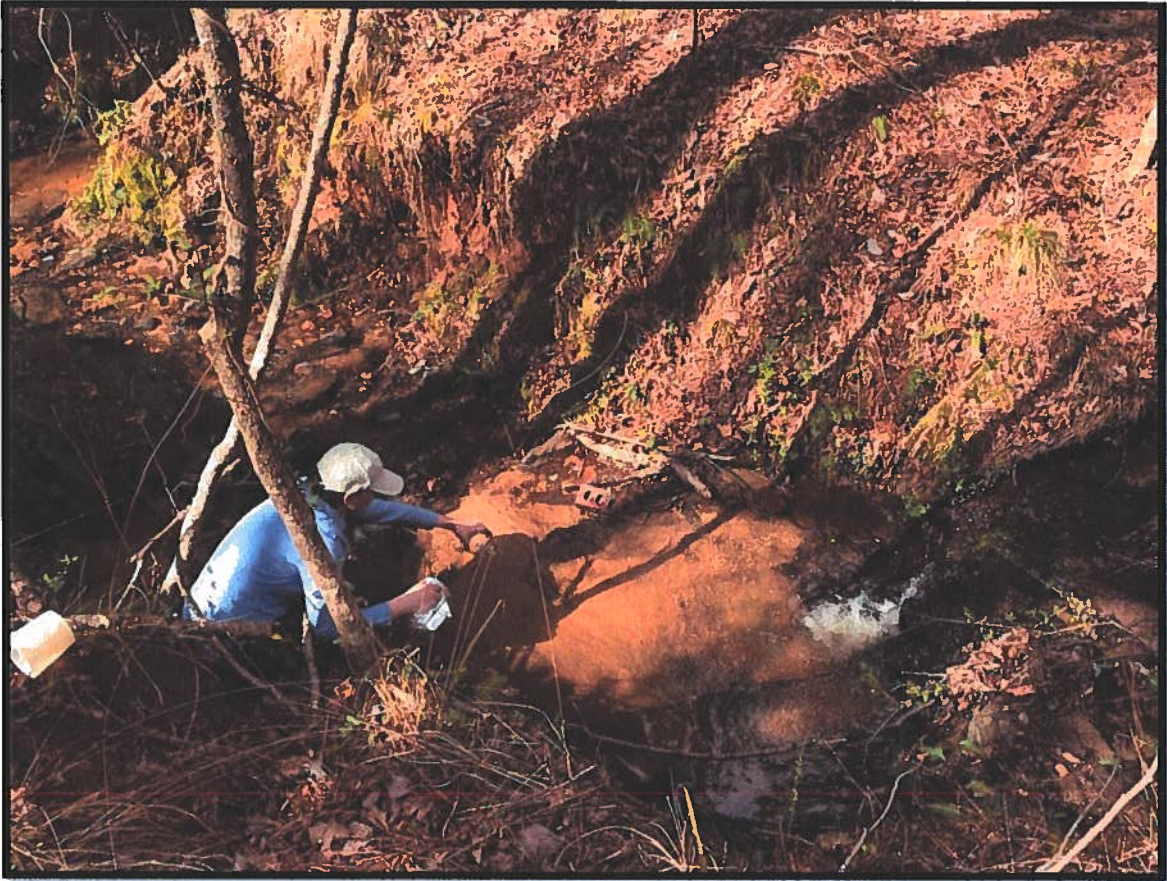
8.0 Pretty Run Basin

Pretty Run basin is a large basin (1,811 acres) located entirely within the city's source water protection area. It is approximately 68% developed as mixed residential with about 8% of that commercial. The remaining 34% is wooded corridors and open space areas. Pretty Run is a priority 1 basin. Pretty Run creek is considered an impaired stream by the state for *fecal coliform* bacteria from a year of monthly samples in 2005 and also has been listed as impaired for biological condition (macroinvertebrates) from a sample that was collected by the state in 2004. These issues require the city to conduct regulated sampling events and studies to try and identify if sewer lines or septic tank leakages that may contain bacterial pollutants are causing the impairments. The city has conducted extensive studies within Pretty Run basin since 2005. The latest study was a sampling study conducted from 2014-2016. The data generated has been analyzed and a report was submitted to DHEC with the annual report in 2016.

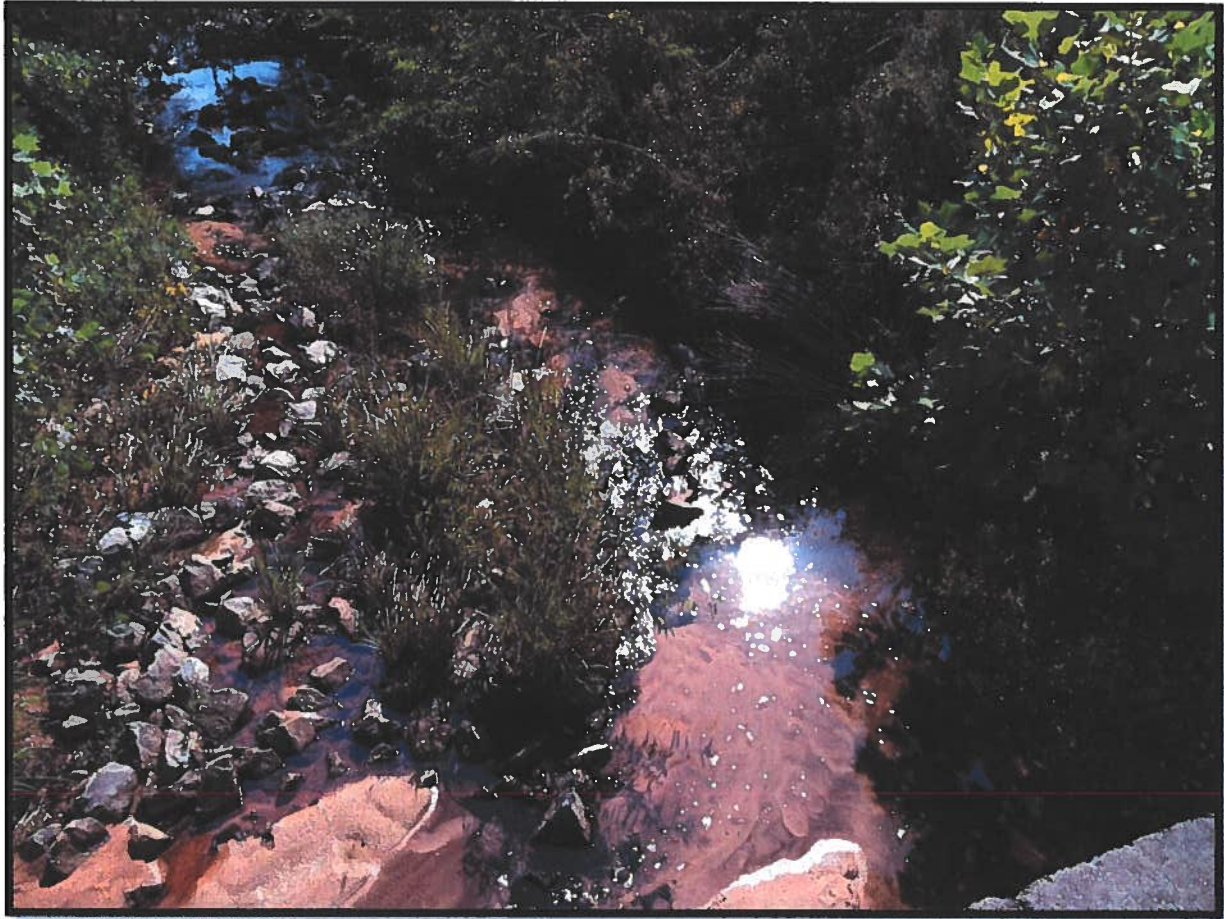
9.0 Waterworks Basin

The Waterworks basin is a large basin (1,208 acres) that handles tremendous flows during rain events. Waterworks basin is a Priority 1 basin. Flows from this basin incorporate stormwater from extensively developed residential and higher density commercial businesses along Knox, Martintown, and Buena Vista Avenue. Approximately 87% of the basin is developed, and that number is growing. The basin enters the river through two separate channels within the River Golf Club.

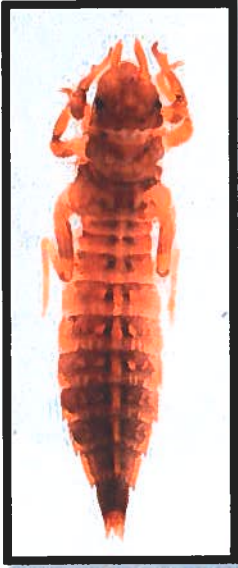
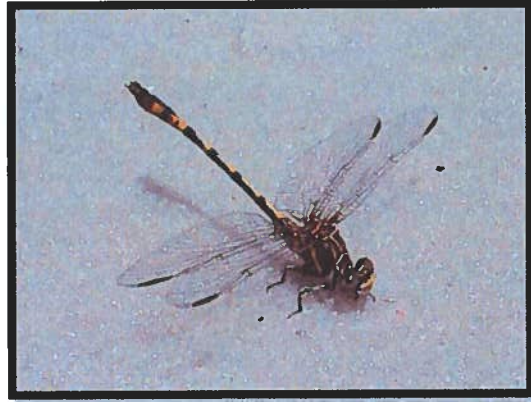
Progomophus sp.

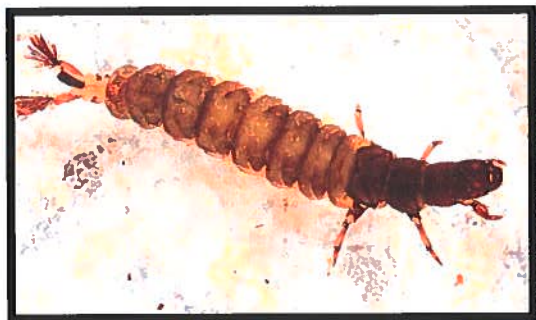
Hydropsyche betteni

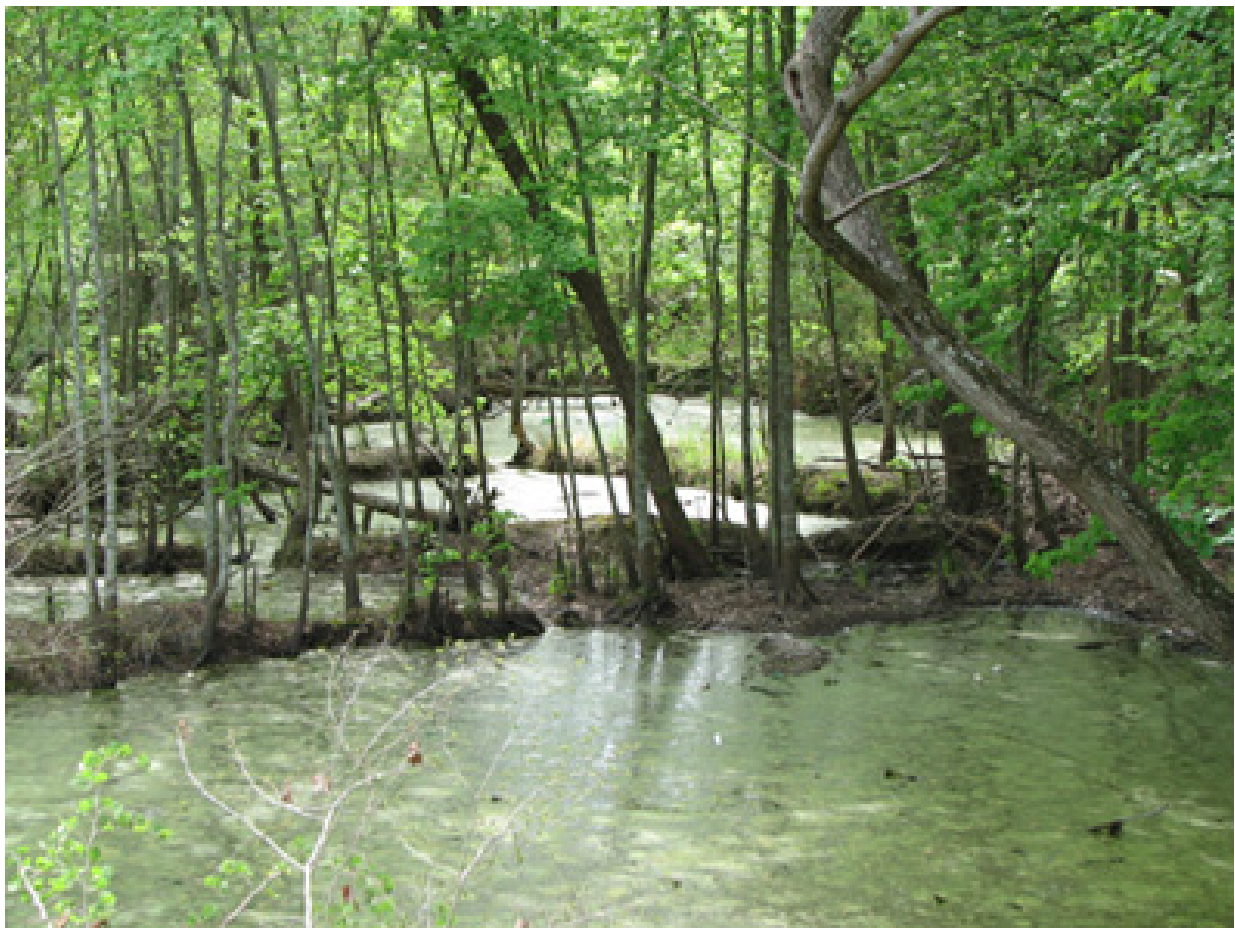
Figure 2. Interconnected depression area serves to diminish stormwater velocity and feed wetland.

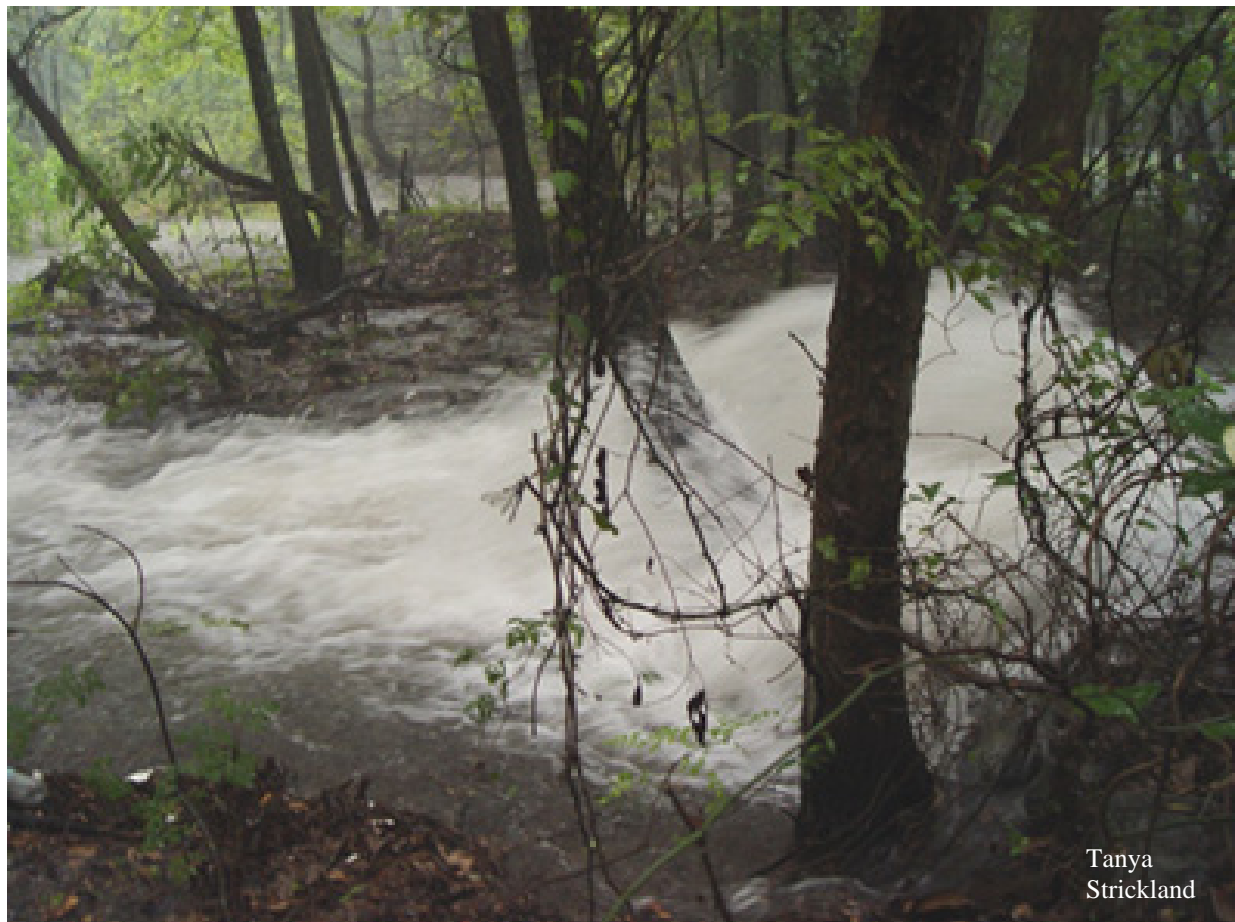
Figure 3. Velocity of stormwater from Georgia Avenue Bridge during heavy rain.

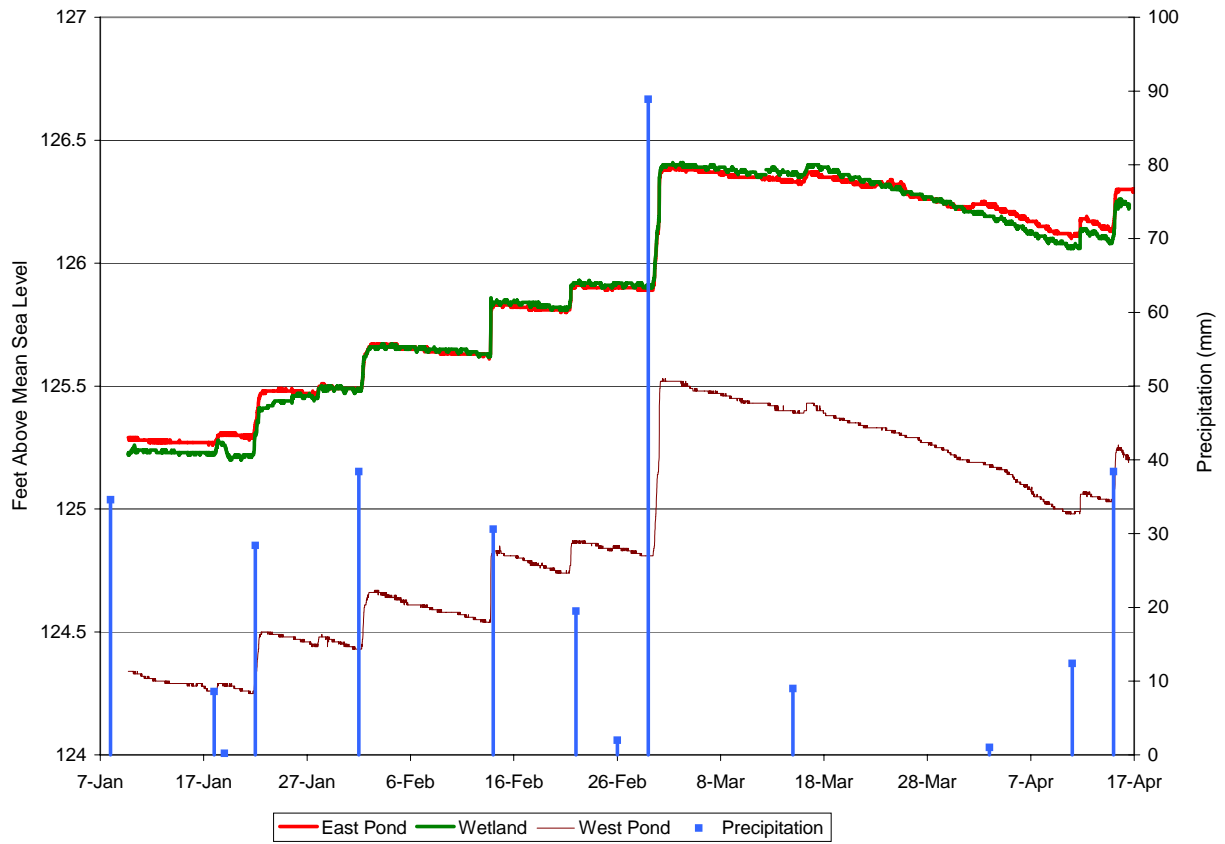
Figure 4. Water level elevation and precipitation at Hammonds Ferry wetland, East Pond, and West Pond.

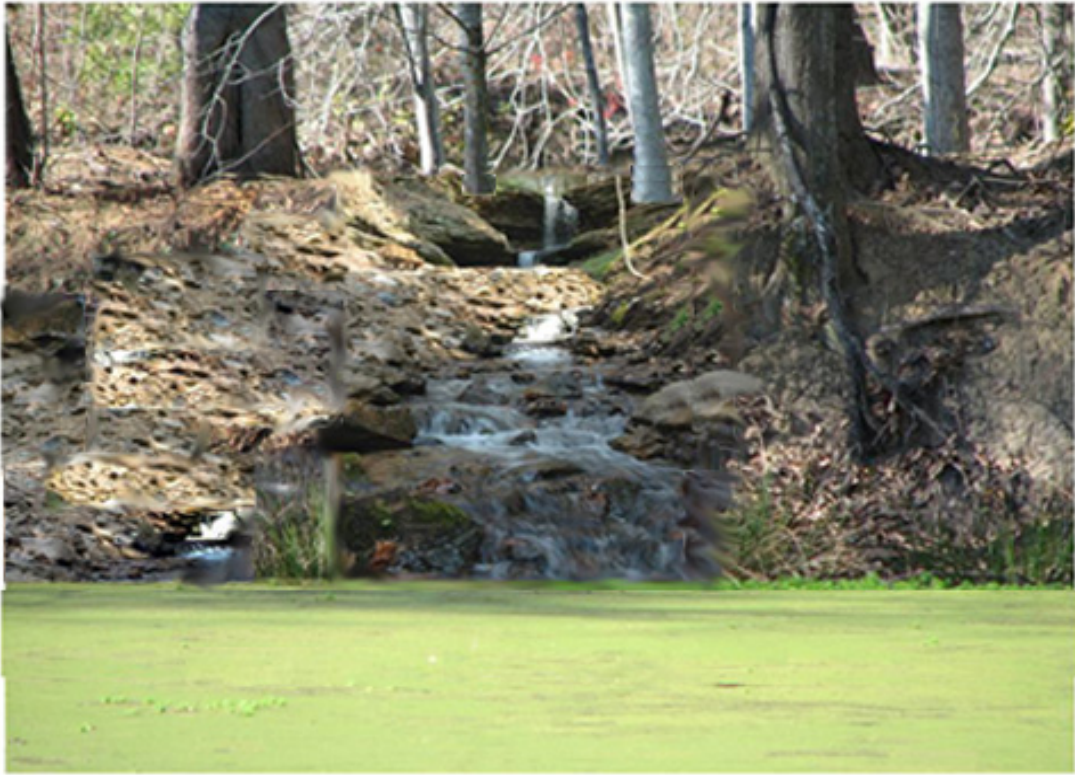
Figure 5. Conceptual waterfall flowing from perched wetland to open water pond.

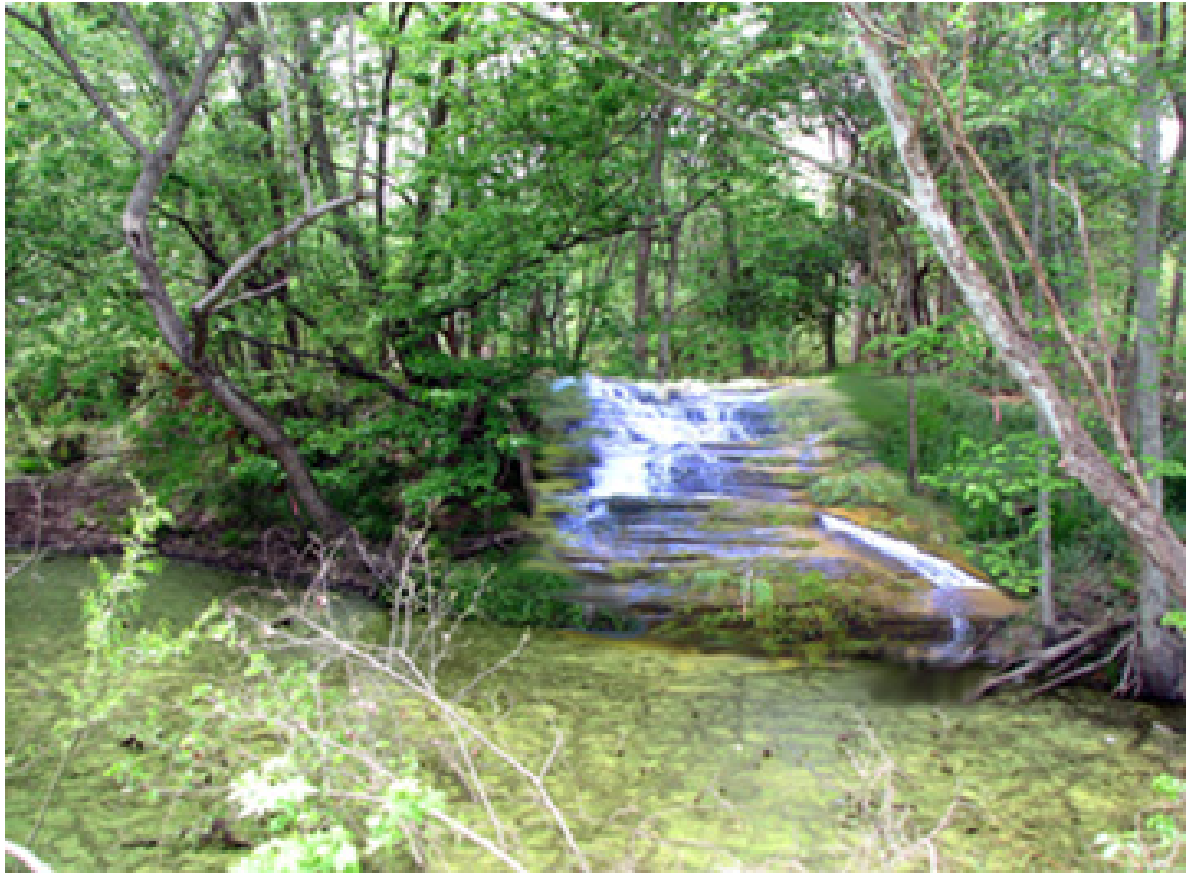
Figure 6. Conceptual waterfall flowing from rerouted feeder stream to depression area.

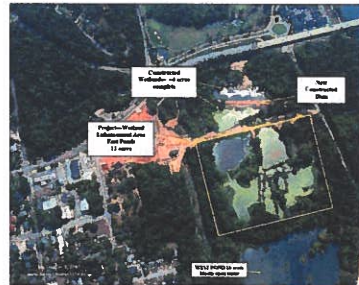
Fig. 3. Aerial view of 30 acres of wetland and upland along Savannah River that is being retrofitted.

Recently, 30 acres of upland and wetland habitat along the Savannah River was retrofitted to treat stormwater from a small municipality. On this site, 23 acres of ponds (borrow pits) exist from an abandoned brick-manufacturing facility. One of the existing ponds was engineered into a constructed wetland and will receive stormwater. The remaining ponds and the last 7 acres of uplands are also being enhanced to improve the ascetic appeal to the community enabling this site to function as an educational ecological park.
