BRICK POND PARK PRE-RESTORATION SURVEY

PRECONSTRUCTION FIELD SURVEY REPORT OF THE NORTH AUGUSTA
CONSTRUCTED WETLAND RESTORATION SITE IN NORTH AUGUSTA, SC

Conducted for the City of North Augusta, SC

June 2007

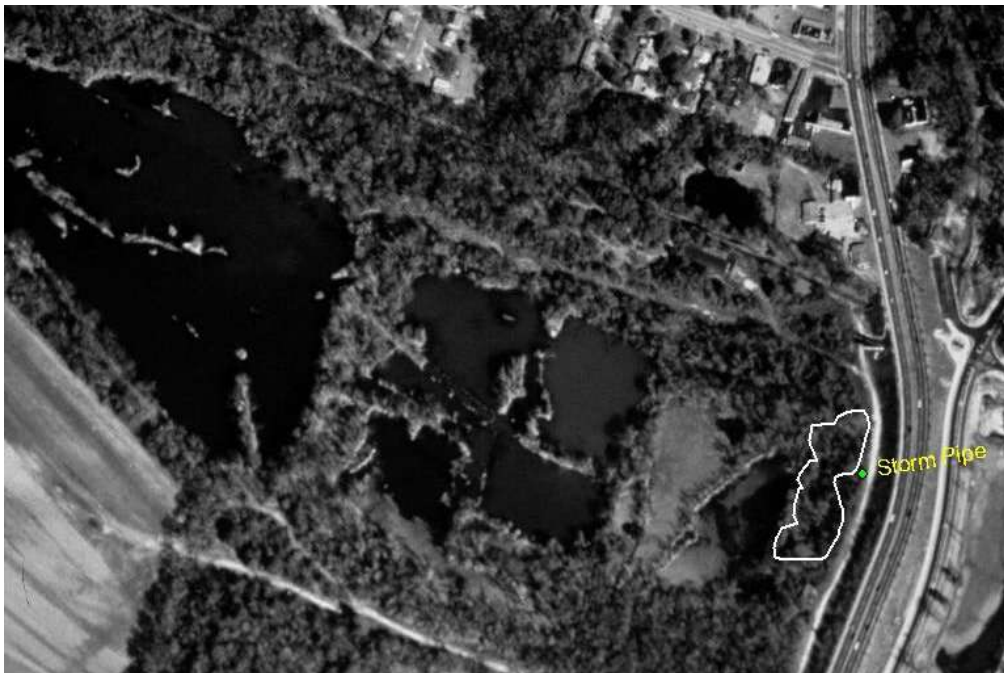
The eastern end of the restoration site is currently a series of ten small ponds (named pools one through ten for this report) that directly receive the majority of the stormwater runoff from this basin (Figure 2) through a 36" concrete stormwater pipe located along the eastern edge of the property (Figure 3).

Figure 2. Pools one through ten and the location of the stormwater pipe that delivers most of the stormwater runoff from the upper regions of the drainage basin.

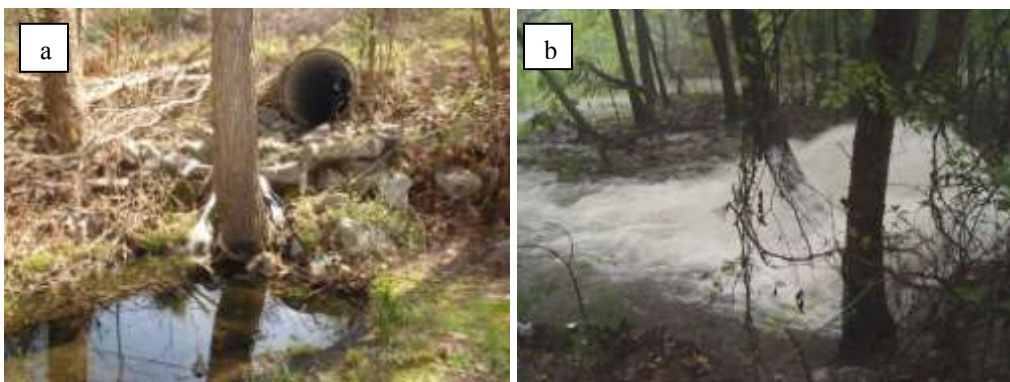
Figure 3. The stormwater runoff pipe into the eastern section of the restoration site during clear weather (a) and during a storm event (b).

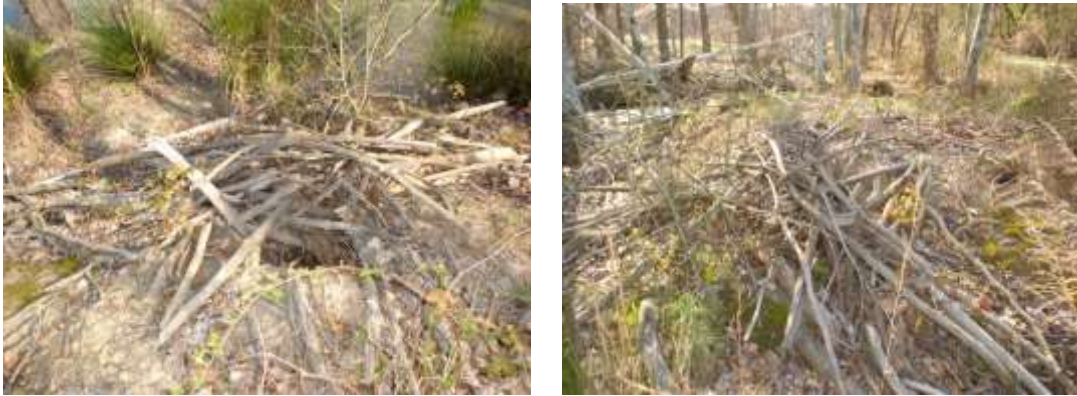
Vegetation in pool seven included parrot feather (*Myriophyllum aquaticum*), another rooted non-native invasive species (SC DNR 1996). The dominant shrub along the banks in this area is another non-native invasive species, privet (*Ligustrum* sp.). Privet is particularly dominant on banks to the north and west of the small pools. Filamentous algae was noted in pool 3, and was later identified in the laboratory as the pollution-tolerant algae, *Spirogyra* sp. Trees along berms and banks in this area included sweetgum (*Liquidambar styraciflua*), willow (*Salix* sp.), elm (*Ulmus* sp.), white mulberry (*Morus alba*), and a number of oaks (*Quercus* sp.). Beaver activity was also noted along the western edge of pool seven (Figure 5); however, the location appeared to be abandoned at the time of this survey.

Figure 5. Beaver activity along the western edge of pool seven.

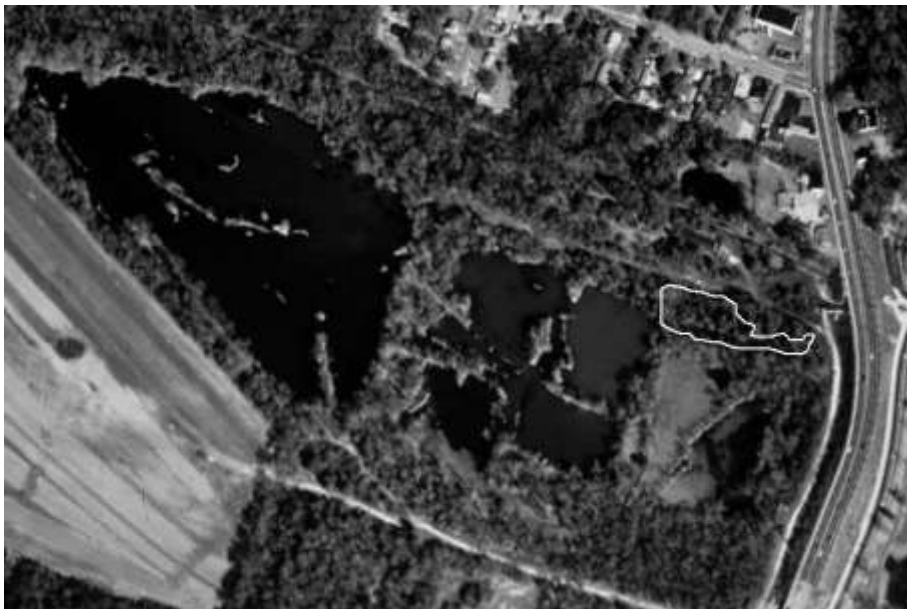
A large beaver pond covers approximately 0.98 acres north of the small ponds, and it is fed by a small stream flowing from off site (Figure 6).

Figure 6. Beaver pond.

Much of the beaver pond will be lost to street construction as part of the development of this property. The perched wetland will be restored as part of the work funded by NFWF.

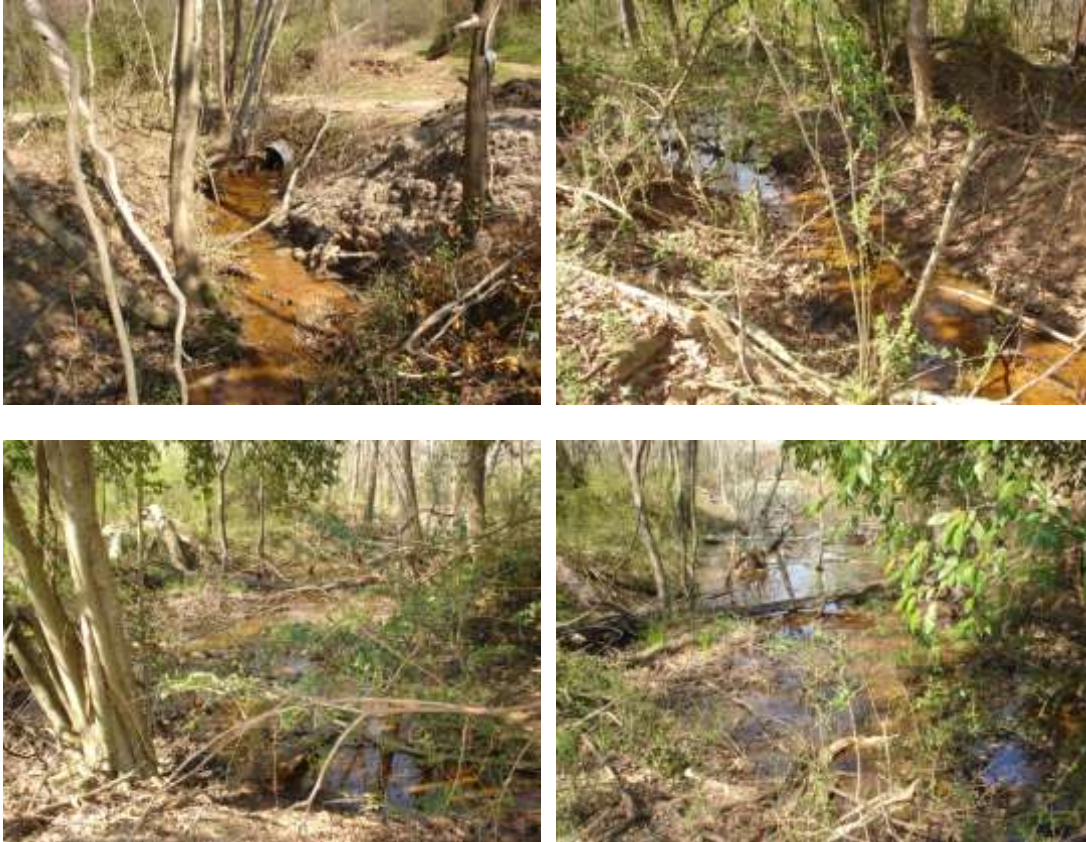
The stream meandered a short distance through thick stands of privet, then opened into the shallow beaver pond (Figure 7). The beaver pond was the most dense area in terms of aquatic vegetation (Figure 8). It was characterized by numerous clumps of rushes (*Juncus* sp.) and a dense cover of duckweed (*Lemna* sp.). Other rooted macrophytes included alligatorweed (*Alternanthera philoxeroides*), parrot feather (*Myriophyllum aquaticum*), cattails (*Typha latifolia* L.), water pennywort (*Hydrocotyl ranunculoides*), and butterweed (*Senecia glabellus*).

Figure 7. Stream flowing from off site and into beaver pond. Stream flows through thick stands of privet.

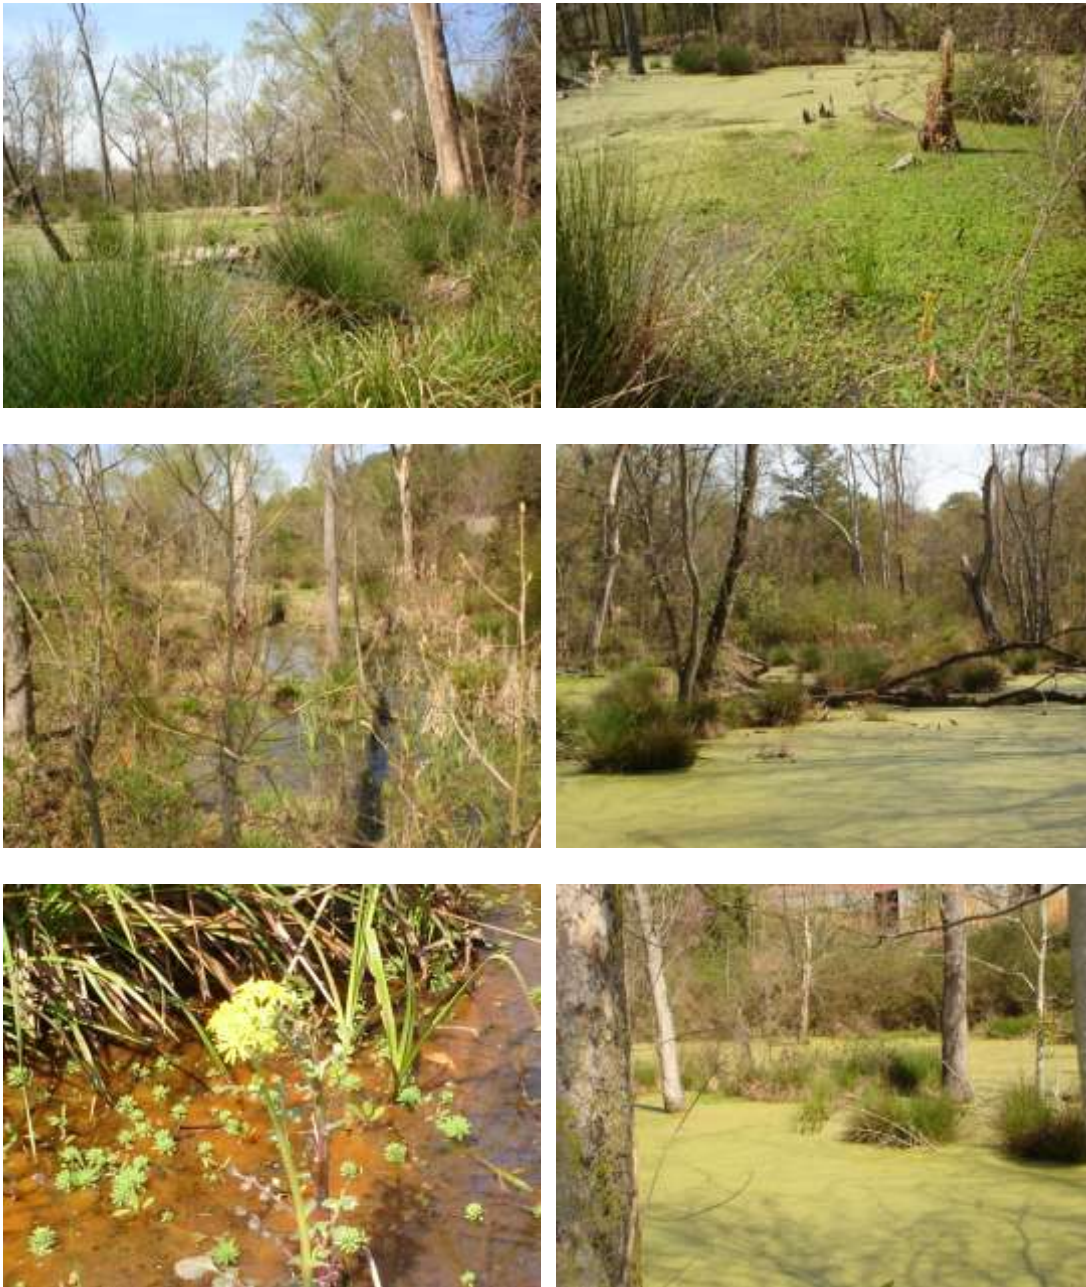
Figure 8. Photographs from the beaver pond showing various vegetation types.

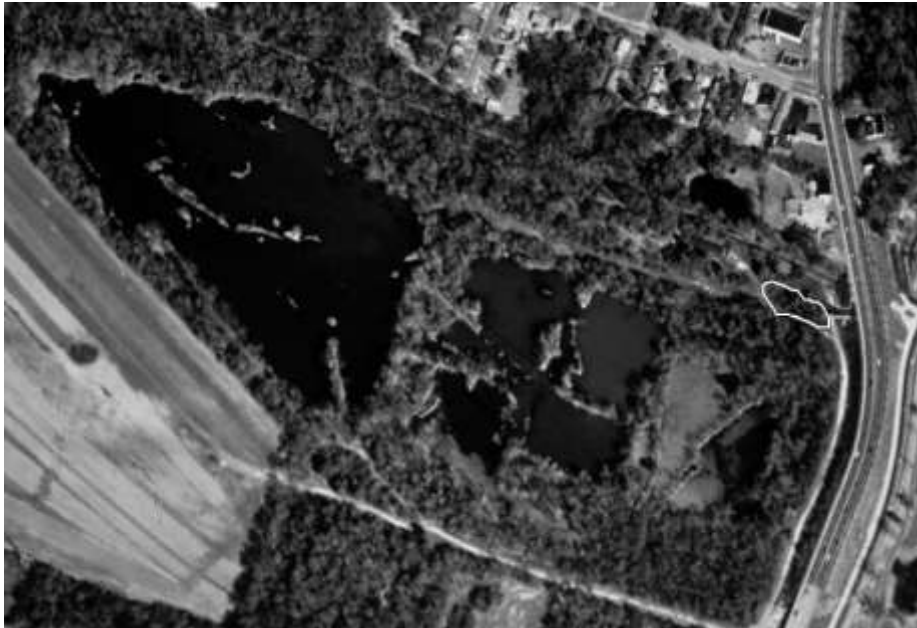
North of the beaver pond, is an area referred to as the "perched wetland" (Figure 9). It is fed by the same ground water stream as the beaver pond. This small area (approximately 0.34 acres) was almost completely covered by parrot feather (*Myriophyllum aquaticum*) and surrounded by small trees, mostly willow (*Salix* sp.) (Figure 10).

Figure 9. The perched wetland.

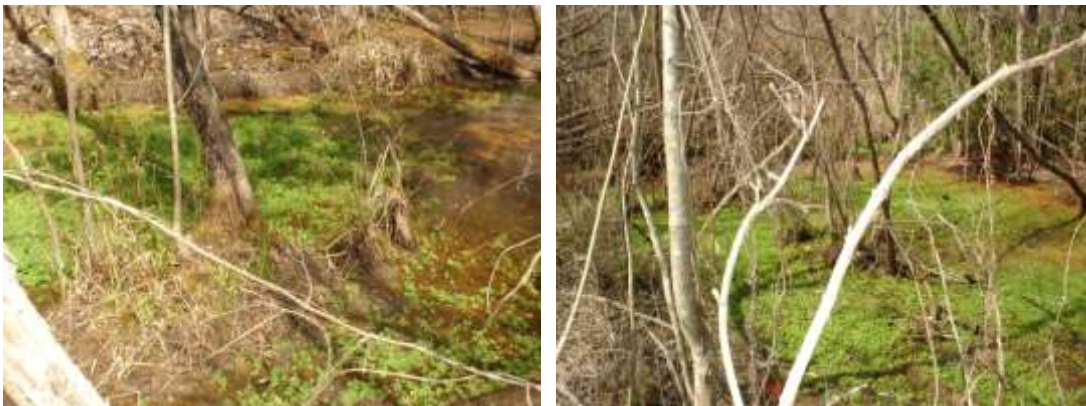
Figure 10. Vegetation in the perched wetland. The dominant aquatic species is parrot feather (*Myriophyllum aquaticum*), and the dominant tree is willow (*Salix* sp.)

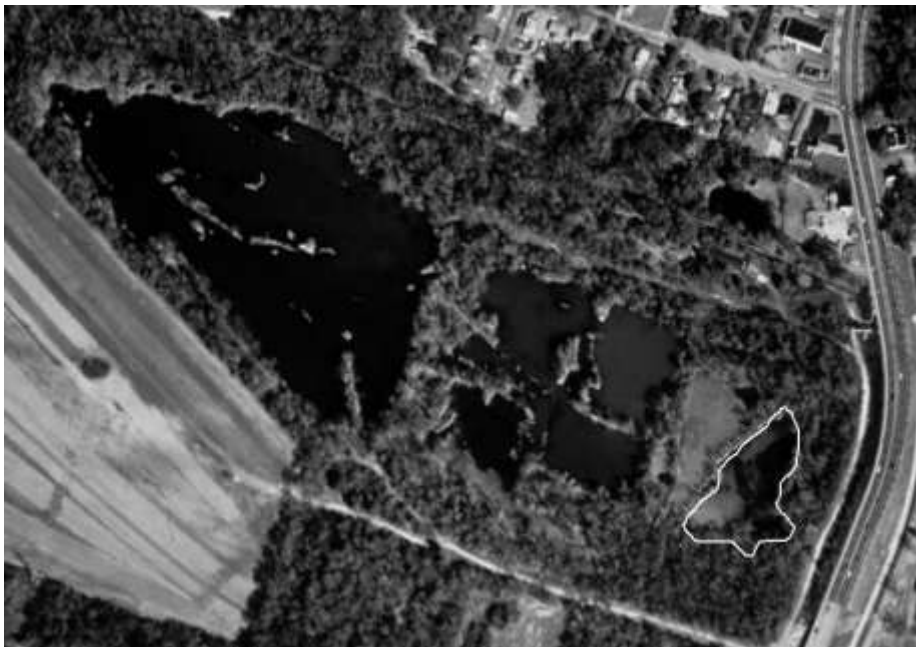
Pond eleven (Figure 11) will be the site of the greatest restoration activity of this project, and this will be the location of the shallow portions of the stormwater treatment wetland. At the time of this survey (prior to restoration activities), pond eleven covered 1.9 acres. Pond fifteen is immediately adjacent to pond eleven (Figure 12) and covered 1.3 acres in April 2007. Once restoration is complete, pond fifteen will serve as the deepest pool of the stormwater treatment wetland. Both ponds were completely covered with duckweed (*Lemna* sp.) and contained large stands of parrot feather (*Myriophyllum aquaticum*) (Figure 13). Rushes (*Juncus* sp.) dominated the littoral zone of both ponds. Privet (*Ligustrum* sp.) was the dominant shrub species on the upper banks surrounding these ponds. Trees noted on banks and berms in this area include wing-barked elm (*Ulmus alata*), poplar (*Populus* sp.), sweetgum (*Liquidamber styraciflua*), and a number of species of oak (*Quercus* sp.).

Figure 11. Pond eleven. After wetland restoration, this pond will serve as the shallow regions of the stormwater treatment wetland.

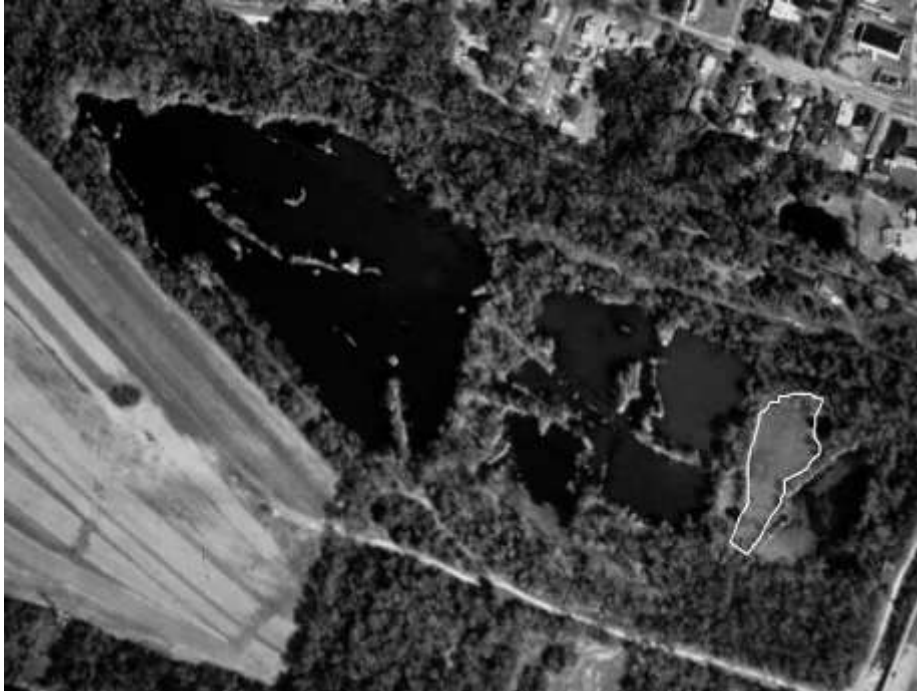
Figure 12. Pond fifteen. This will serve as the deepest pool for the stormwater treatment wetland.

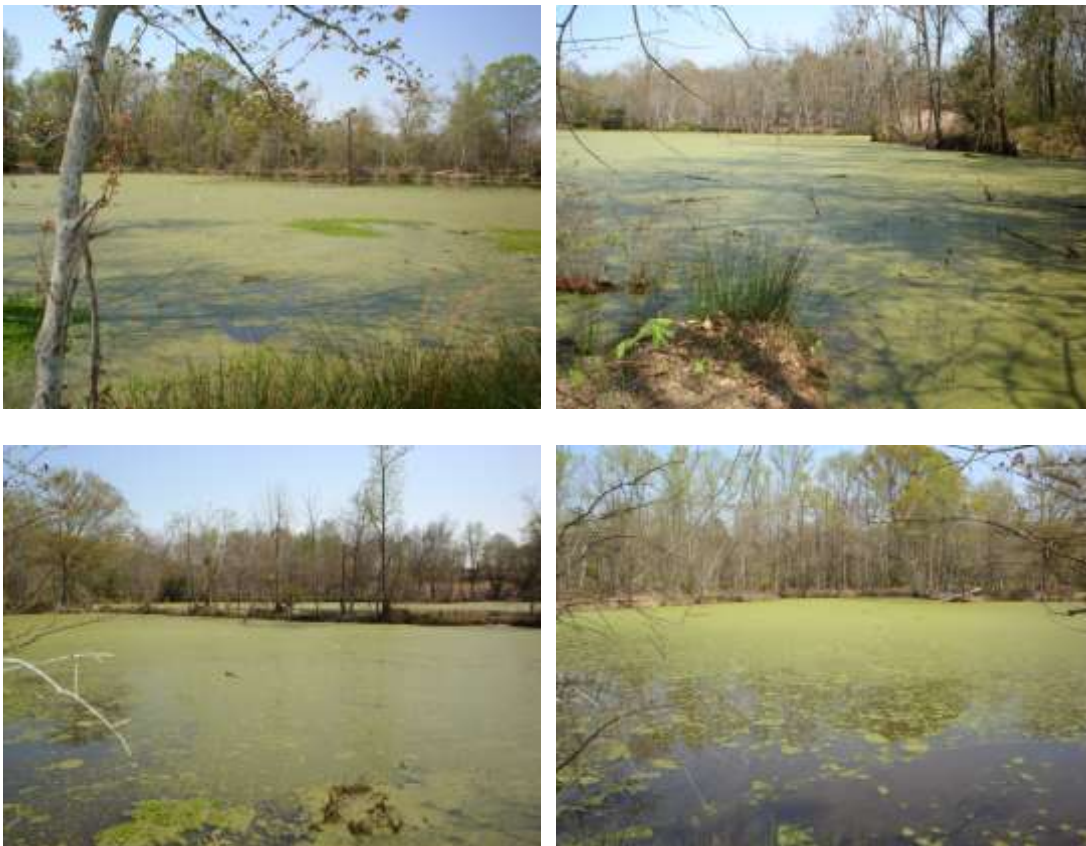
Figure 13. Close up views of ponds eleven and fifteen. These two ponds will be restored into a stormwater treatment wetland.

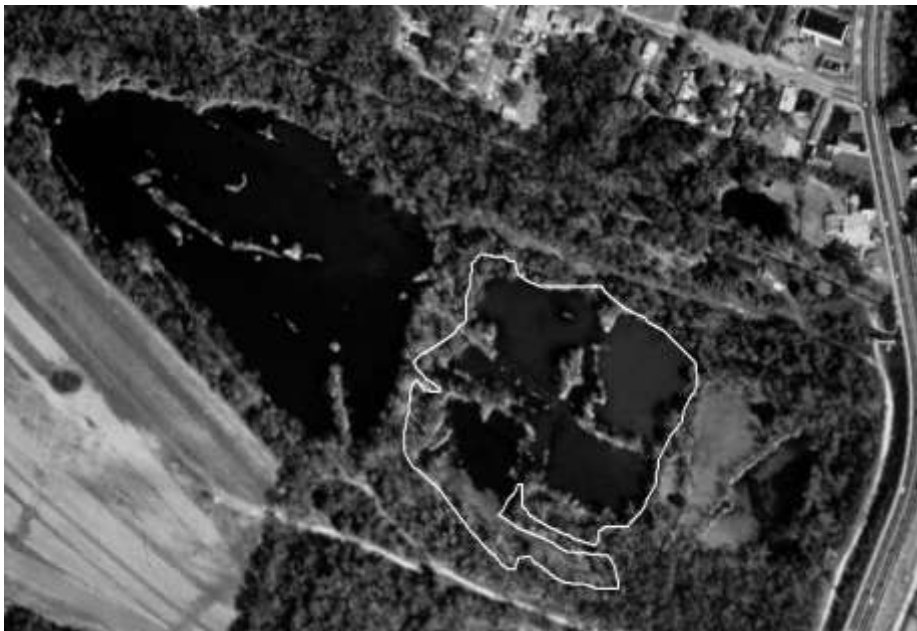
Pond thirteen is the largest pool on the eastern side of the property and is characterized by a number of berms from former mining activities (Figure 14). Berms separate individual pools, but all have been broken to allow flow through one contiguous system (Figure 15). As with ponds eleven and fifteen, this large pond was completely covered by duckweed (*Lemna* sp.) and parrot feather (*Myriophyllum aquaticum*). Rushes (*Juncus* sp.) were present in the littoral zone, and privet (*Ligustrum* sp.) was the dominant shrub species on the upper banks, particularly to the south and west. One adult American alligator (*Alligator mississippiensis*) and at least three juveniles (< 6 inches long) were observed in the northwest corner of this pond. Trees noted along the banks and berms of pond thirteen include willow (*Salix* sp.), elm (*Ulmus* sp.), poplar (*Populus* sp.), sweetgum (*Liquidamber styraciflua*), red maple (*Acer rubrum*), and a number of different oaks (*Quercus* sp.).

Figure 14. Pond thirteen, the largest pond on the eastern side of the property's land bridge.

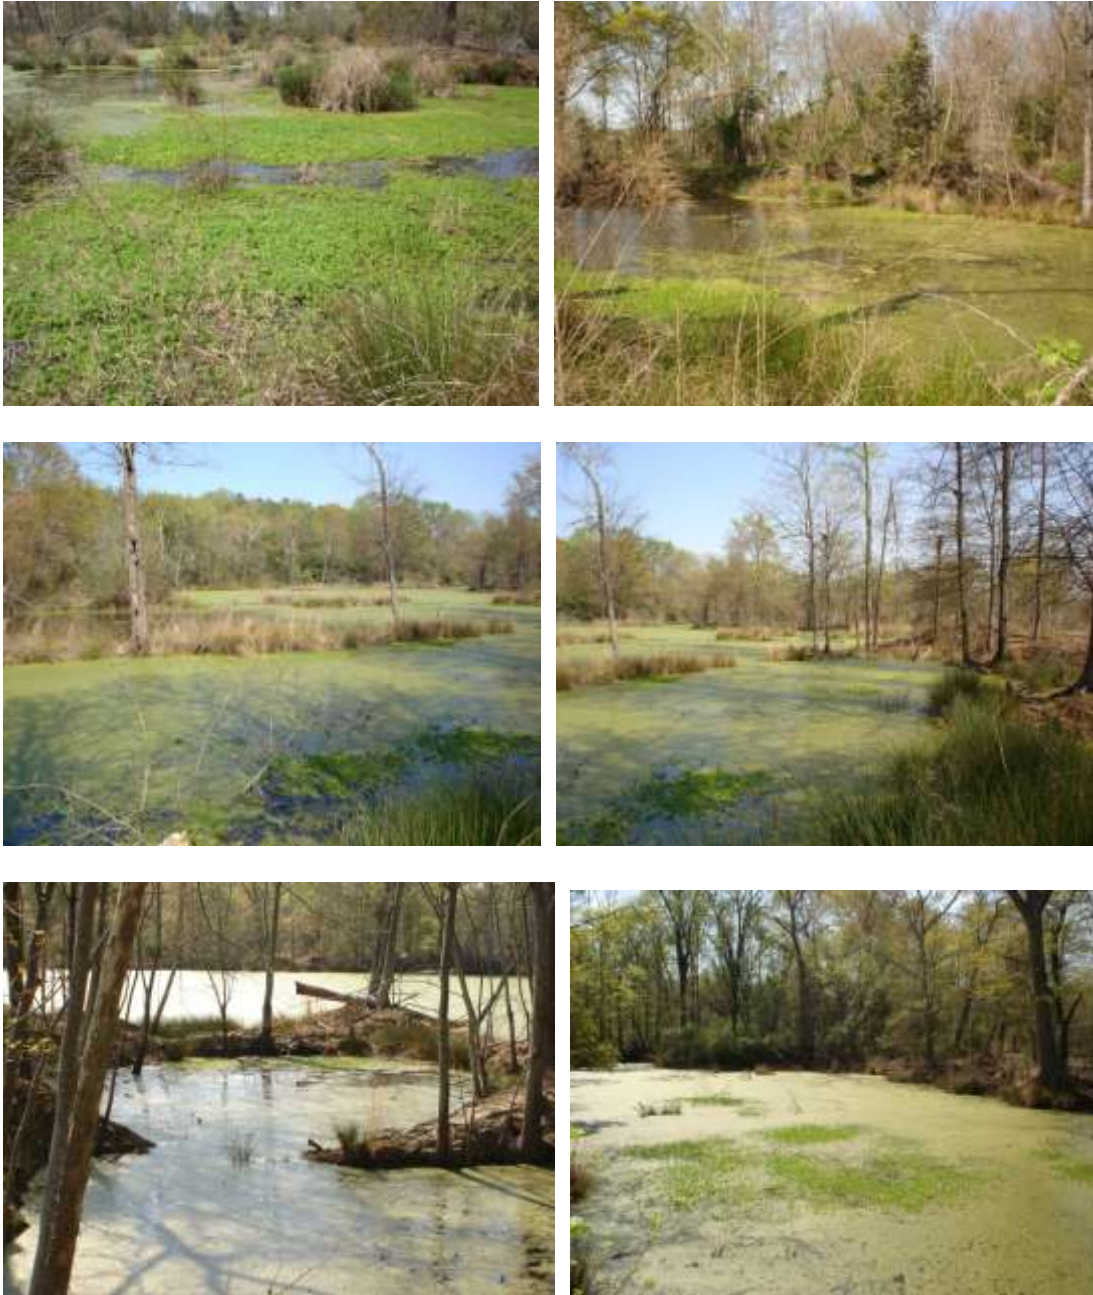
Figure 15. Photographs of pond thirteen. Numerous berms outline the former clay quarries. All berms have been breached in order to provide one contiguous wetland system.

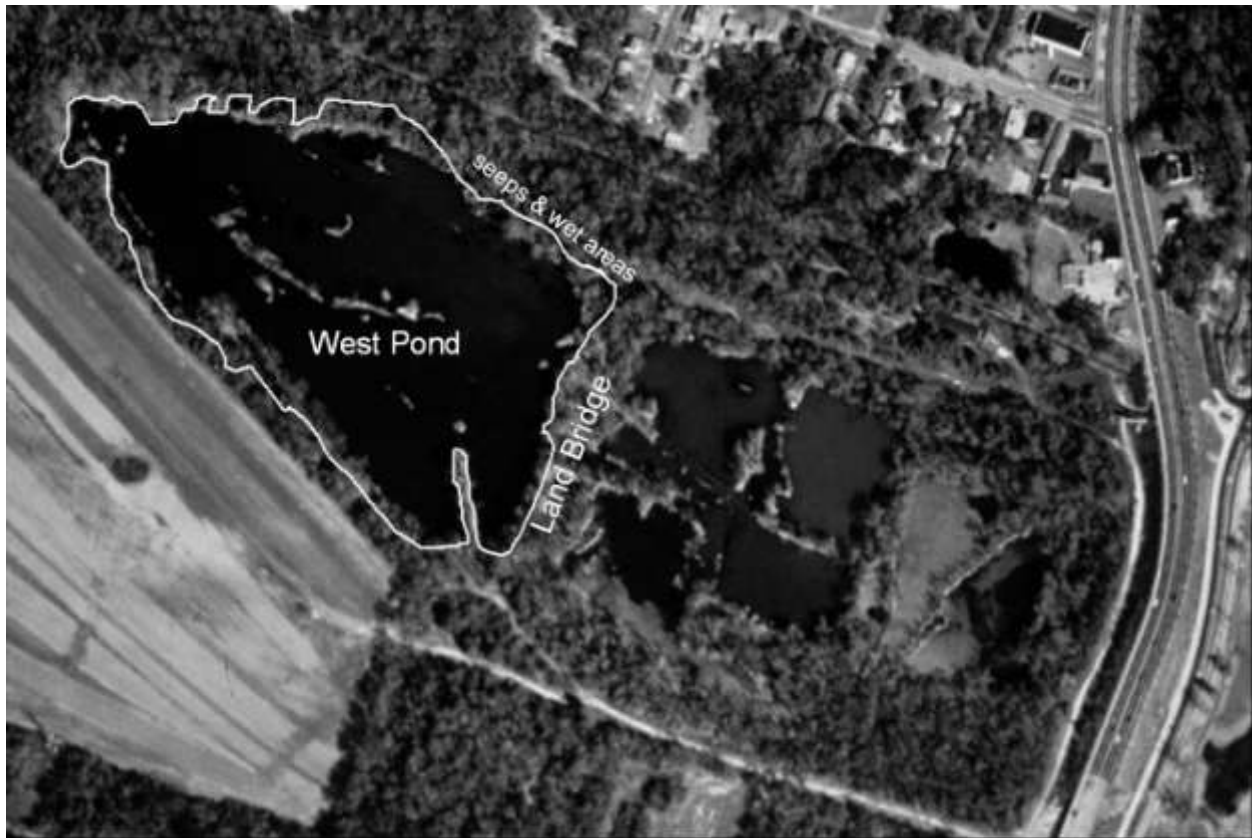
The west pond is located west of the land bridge and is the largest pond on the property, covering approximately 17.8 acres (Figure 16). There are a number of islands and small isolated pools along the perimeter that are remnants of a once-extensive berm system created during mining activities. There was a large cover of the aquatic nuisance alligatorweed (*Alternanthera philoxeroides*) along with parrot feather (*Myriophyllum aquaticum*) in shallow regions around the pond's perimeter (Figure 17). The pollution-tolerant filamentous algae, *Spirogyra* sp., was also observed in shallow areas along with the alligatorweed. Other rooted macrophytes included spotted pond weed (*Potamogeton pulcher*) and cattails (*Typha latifolia* L.). Rushes (*Juncus* sp.) were present in the littoral zone along the entire perimeter. Upper banks on the north and south sides of west pond held dense stands of privet (*Ligustrum* sp.). Trees surrounding west pond include poplar (*Populus* sp.), hackberry (*Celtis* sp.), sweetgum (*Liquidambar styraciflua*), black cherry (*Prunus serotina*), willow (*Salix* sp.), elm (*Ulmus* sp.), red maple (*Acer rubrum*), and a number of oak species (*Quercus* sp.).

Figure 16. West pond.

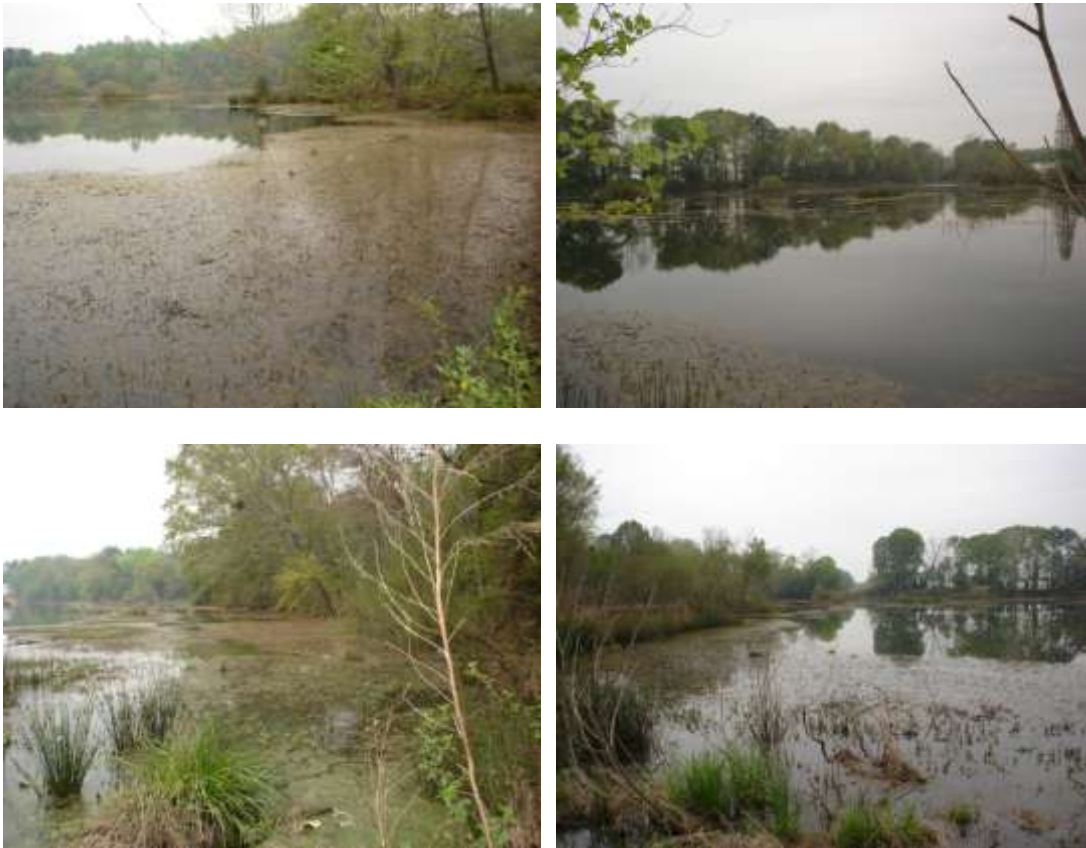
Figure 17. Photographs of west pond.

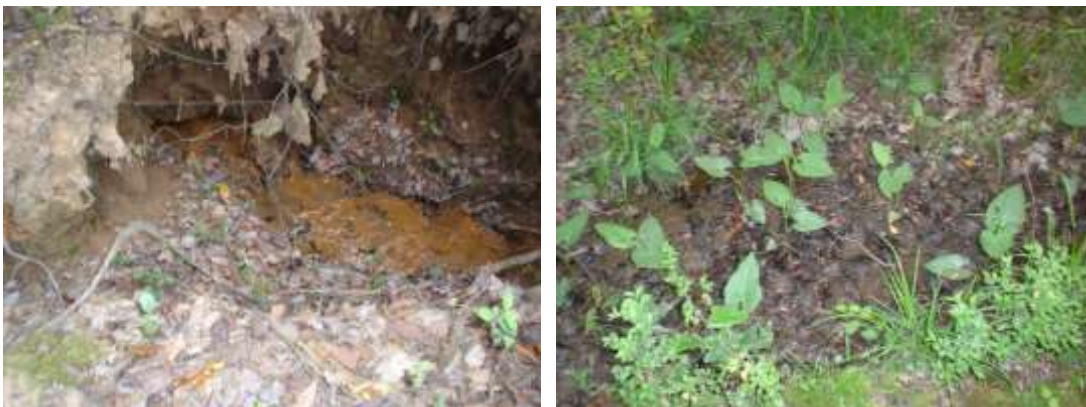
The northeastern bank of west pond contained several springs and isolated wet areas (Figure 18) characterized by lizard's tail (*Saururus cernuus* L.), a common wetland plant, and a dense stand of cane (*Arundinaria gigantea*) at the northeastern corner. The cane stand extended onto the land bridge to the eastern side of the land bridge road. Several species of ferns were also observed along the wet areas of the land bridge; these included cinnamon fern (*Osmunda cinnamomea*) and chain fern (*Woodwardia areolata*).

Figure 18. A spring along the northern bank of west pond and its associated wetland vegetation.

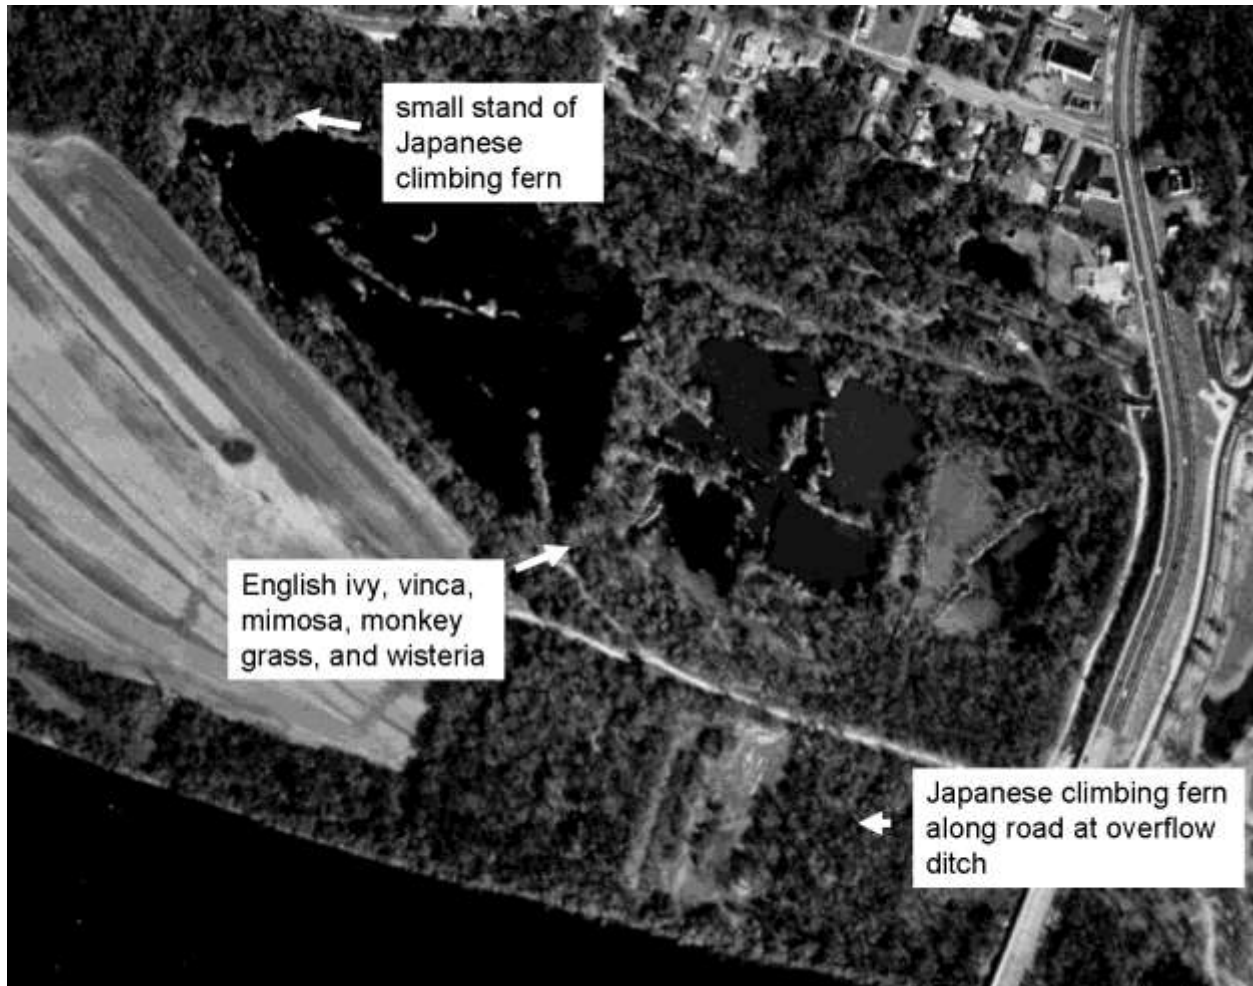
Several terrestrial invasive plants were observed in addition to privet and all of the aquatic nuisance species listed in the descriptions above. English ivy (*Hedera helix*), vinca (*Vinca* sp.), mimosa (*Albizia julibrissin*), monkey grass (*Ophiopogon* sp.), and wisteria (*Wisteria* sp.) were all observed on the land bridge between east and west ponds. These plants are of note because of their non-native status and invasive nature. Japanese climbing fern (*Lygodium japonicum*), another highly invasive non-native terrestrial plant, was noted along the northwestern shore near the recently developed residential area and along the road adjacent to emergency overflow ditch between the restoration site and the Savannah River (Figure 19).

Figure 19. Notable stands of invasive terrestrial vegetation in addition to privet. Privet is the dominant shrub throughout the entire property.
