**NORTH AUGUSTA  
WATER QUALITY & STREAM ASSESSMENT 2007 to 2020**

**April 2021**

This report was prepared by  
Tanya Strickland, Stormwater Superintendent  
Michaela Canady, Editor  
City of North Augusta, Stormwater Management Department

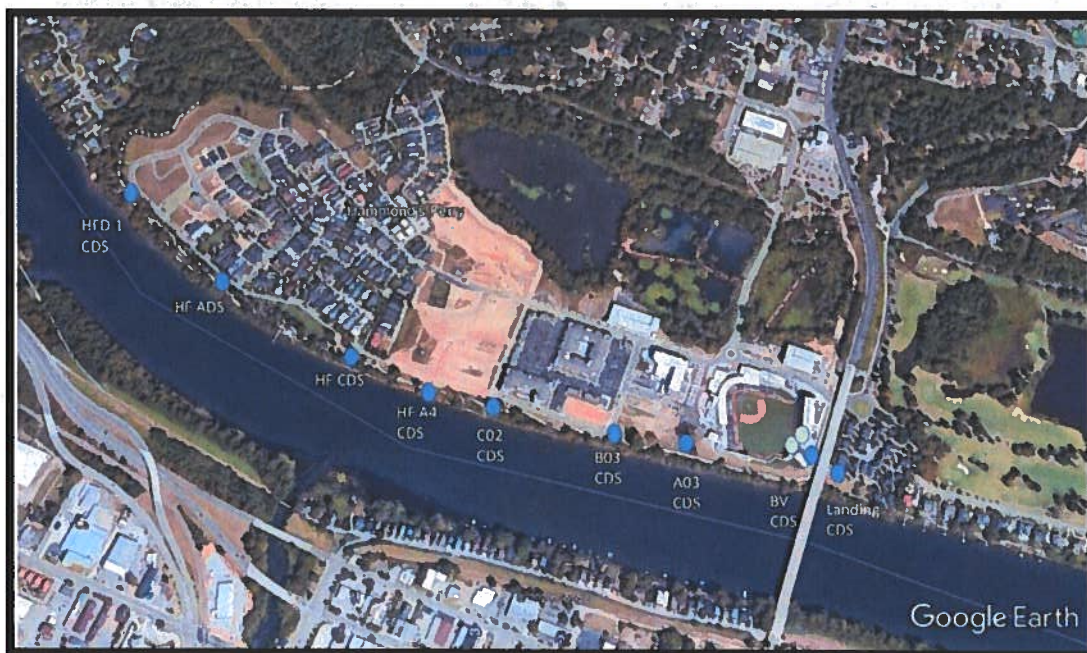
Figure: 4.1 North Augusta Riverfront development underground stormwater treatment unit locations.

Newer projects require a water quality treatment features. This includes the Brick Pond Park stormwater treatment system for the upper reaches of the basin and also underground treatment units have been added along the riverfront to capture and treat stormwater runoff to reduce pollutant loads entering the Savannah River from the riverfront development. Brick Pond Park treats stormwater from for projects located above Railroad Avenue. As for the development below Railroad Avenue, individual underground treatment units are installed at the final point in the stormwater system before water is discharged to the river (see Figure 4.1 below). Each blue dot is an individual treatment unit at the end of the stormwater system. The underground units' capture and collect sediment, oils and trash that enters the storm drains during storms.

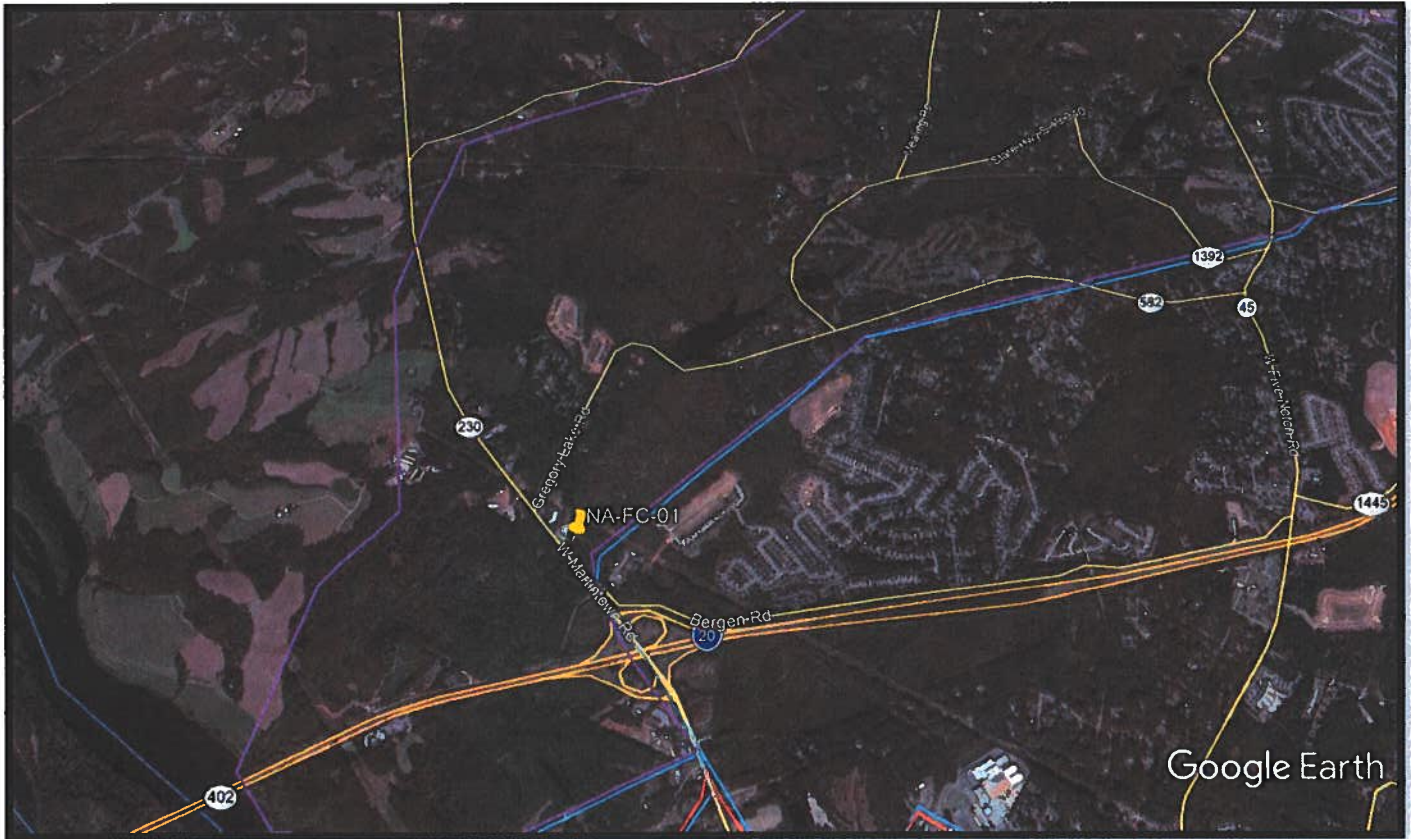
Water quality samples are pulled below the Greg's Gas Plus at sample point NA-FC-01 located on Martintown Road near Gregory Lake Road (pictured above and shown below). This is the bottom reach of the basin. A secondary sample point at Gregory Lake Road is NA-FC-02. Much of the basin is outside of the city limits of North Augusta and tributaries that are completely outside of the city limits are not sampled.

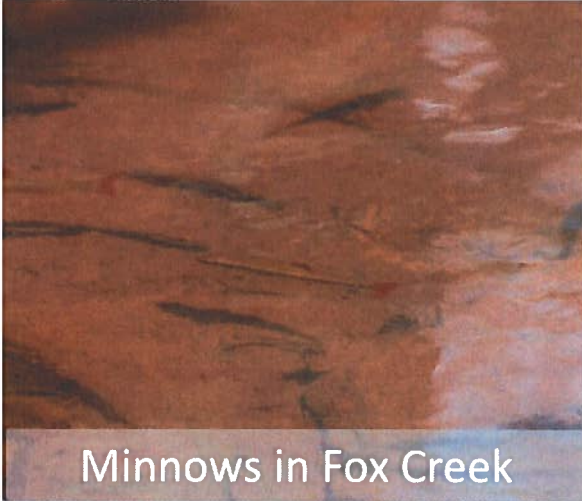
The stream reach at the sample location appears healthy with many areas of cover for aquatic insects, the substrate of the stream is rocky, sandy and contains pebbles as well. Overhanging vegetation is present throughout the reach all of which indicate a good habitat.

The native minnow, the dusky shiner (*Notropis cummingsae*) is routinely seen swimming in the stream. The photo to the left is of breeding male shiners (color on fin tips). It was taken at Fox Creek in 2009. Fish of this description were collected in 2008 from Pole Branch for professional identification by researchers at USC-Aiken. These appear to be the same species.

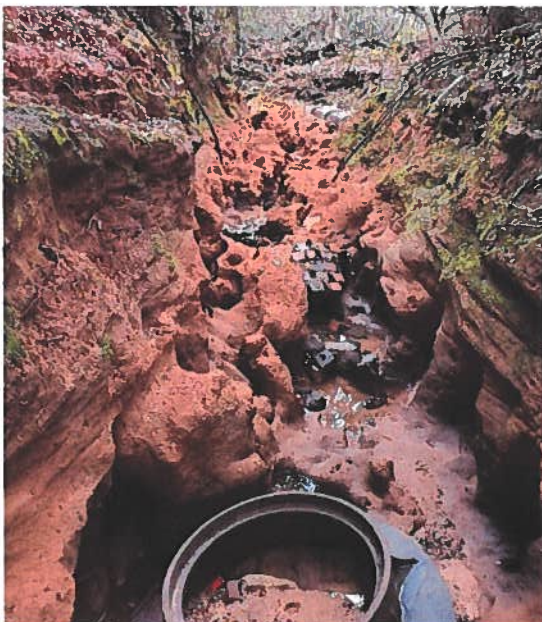
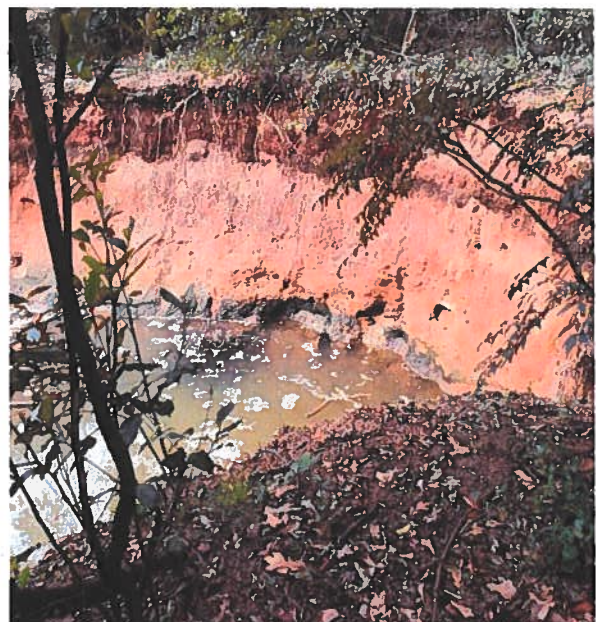
The basin has been affected by excessive flows. Channel integrity is degraded with erosion and incision occurring in channels within the entire basin. Newer developments within the upper basin flows through detention ponds to reduce the release rate. Older shopping centers development within that same area do not. Lowes, River Commons, Shoppes at North Augusta and Walmart are new projects that provided detention. Other older shopping areas on Martintown Road, Knox and along Atomic Road do not. The combination of unretained from these locations along with SCDOT roadways entering the same pipe infrastructure as the newer detained flows has the system at its maximum capacity. At the outfalls of the system, it is obvious there is a problem. The flow is creating deep ravines, failing slopes on channels, sediment loads within the channels, impacted storm system and sanitary infrastructure, and flooding.

In addition to storm conveyances failing, stormwater pipes in streets have failed, ponds have failed, and commercial infrastructure has failed in the area. The city has relined many feet of pipes that were causing road failure in Woodlawn Place over the past few years. A pond and its piping failed adjacent to that location from a condominium complex. An additional failure occurred along the length of the entire complex at one apartment complex. These failures have also impacted existing infrastructure downstream.

This area would benefit from a comprehensive review to identify areas where regional detention could be accomplished. Unfortunately, there is not a lot of available locations for that to work. For this reason, all redevelopment within this area on larger tracts that don't currently provide some sort of detention, should consider it. The city must consider this as well, and work toward processing development proposals within the basin that will not create more problems, but could solve existing ones.

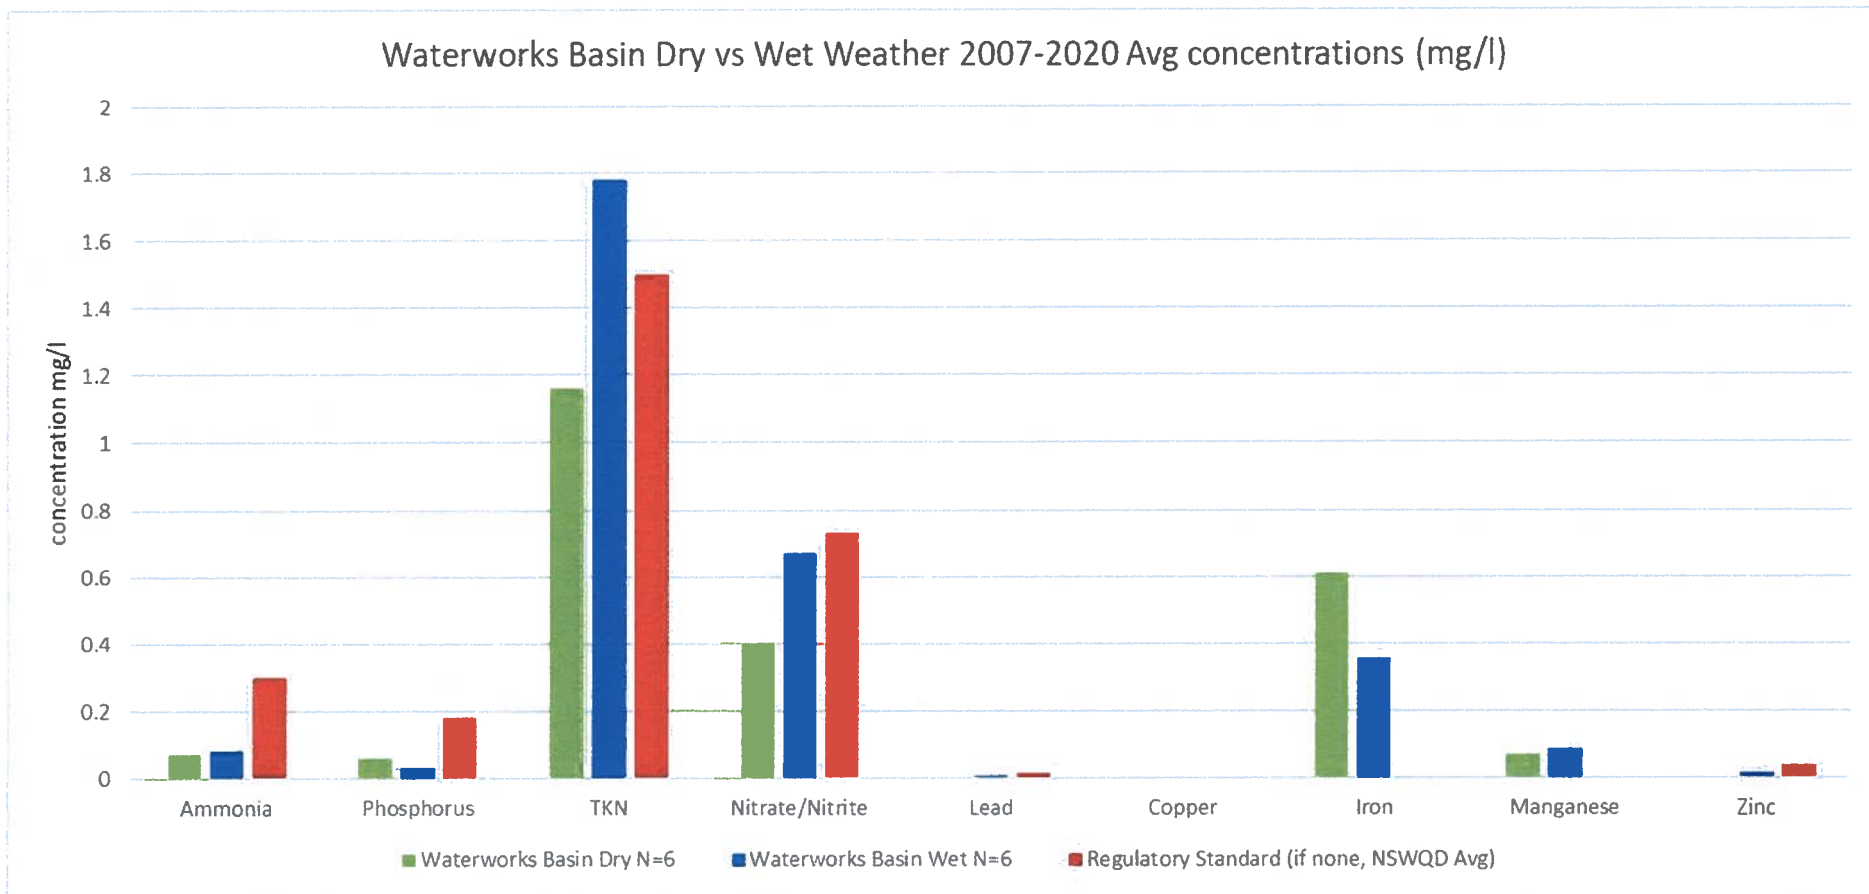
Figure 9.1: Waterworks Data Dry Vs Wet Weather Results graph

Waterworks basin sampling results show TKN and Nitrate/nitrite levels are above averages or standards (Table 9.1). These numbers could indicate pollutants entering the system. The principle sources of nitrate contamination in water are fertilizers, animal waste and septic wastes. We have all three concerns in this part of the basin. Comparison between dry and wet sample events also show some elevated levels of TKN but overall the numbers are still within range of what we normally see in stormwater sampling (Figure 9.1).

Wetlands remove pollutants, and that is observed during dry and wet weather sampling. During one dry weather sample event we pulled a sample upstream near the Greenway Trail entrance on Riverside Boulevard NA-WW-05, (Nitrate = 1.4 mg/l, high) and then one downstream before the water leaves River Club Golf Course area NA-WW-01, (Nitrates = 0.75 mg/l) at the stream entrance to Savannah River. Also, during a wet weather sample event we pulled a sample upstream at NA-WW-05, (TKN=8.3 mg/l, extremely high) and then one downstream again NA-WW-01, (TKN=0.92 mg/l) at Savannah River. This is an example of how well wetlands in that area remove pollutants in Waterworks Basin. We know that the water leaving the basin to the Savannah River is less polluted than samples taken upstream of the wetlands. Many of the samples are pulled upstream, samples pulled at the outfall, NA-WW-01 confirm that.

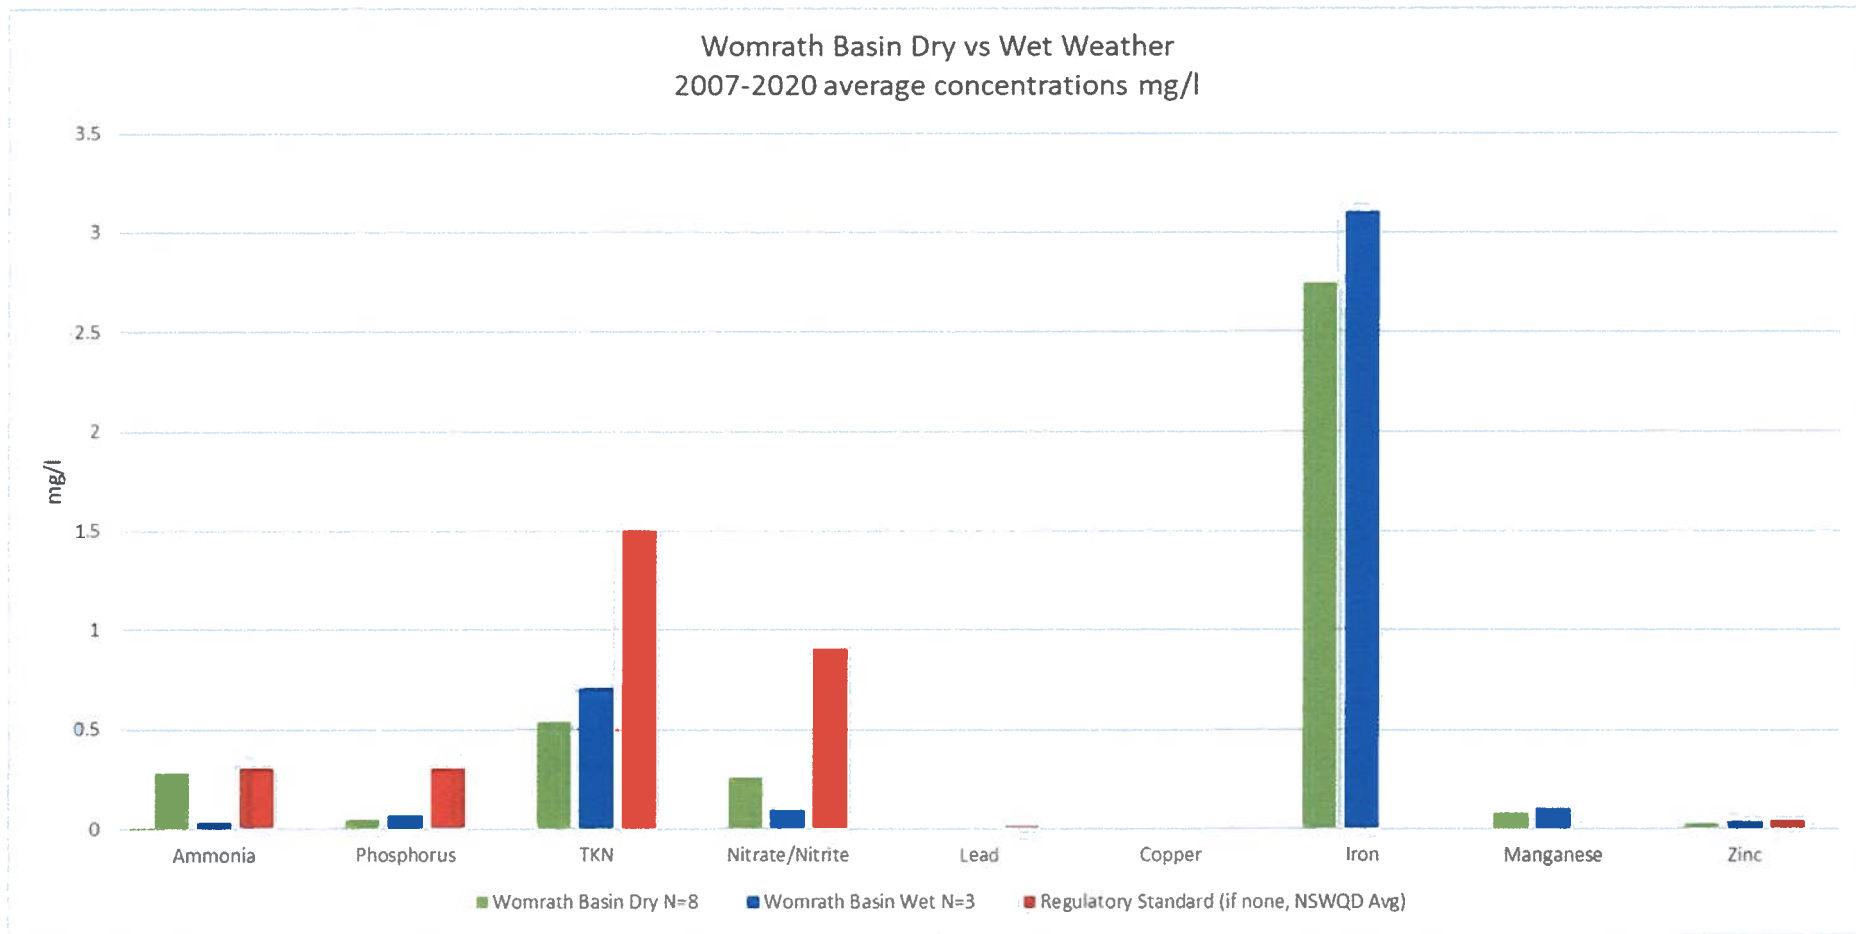
Figure 10.1: Womrath Basin Data - Dry Vs Wet Weather Results graph

Sampling results for this basin are good. Most of the data indicate no substantial pollutants of concern (see Table 10.1). During heavy rainfall, there is a potential for increased levels of pollutants entering the stream channel due to surcharging of sewer lines. This has been reported to staff by citizens from the sewer lines that run down Womrath Road. Data from wet vs dry weather sampling is shown in Figure 10.1. While there are some indications of higher nutrient levels in individual samples, none are over the average seen in stormwater sampling.

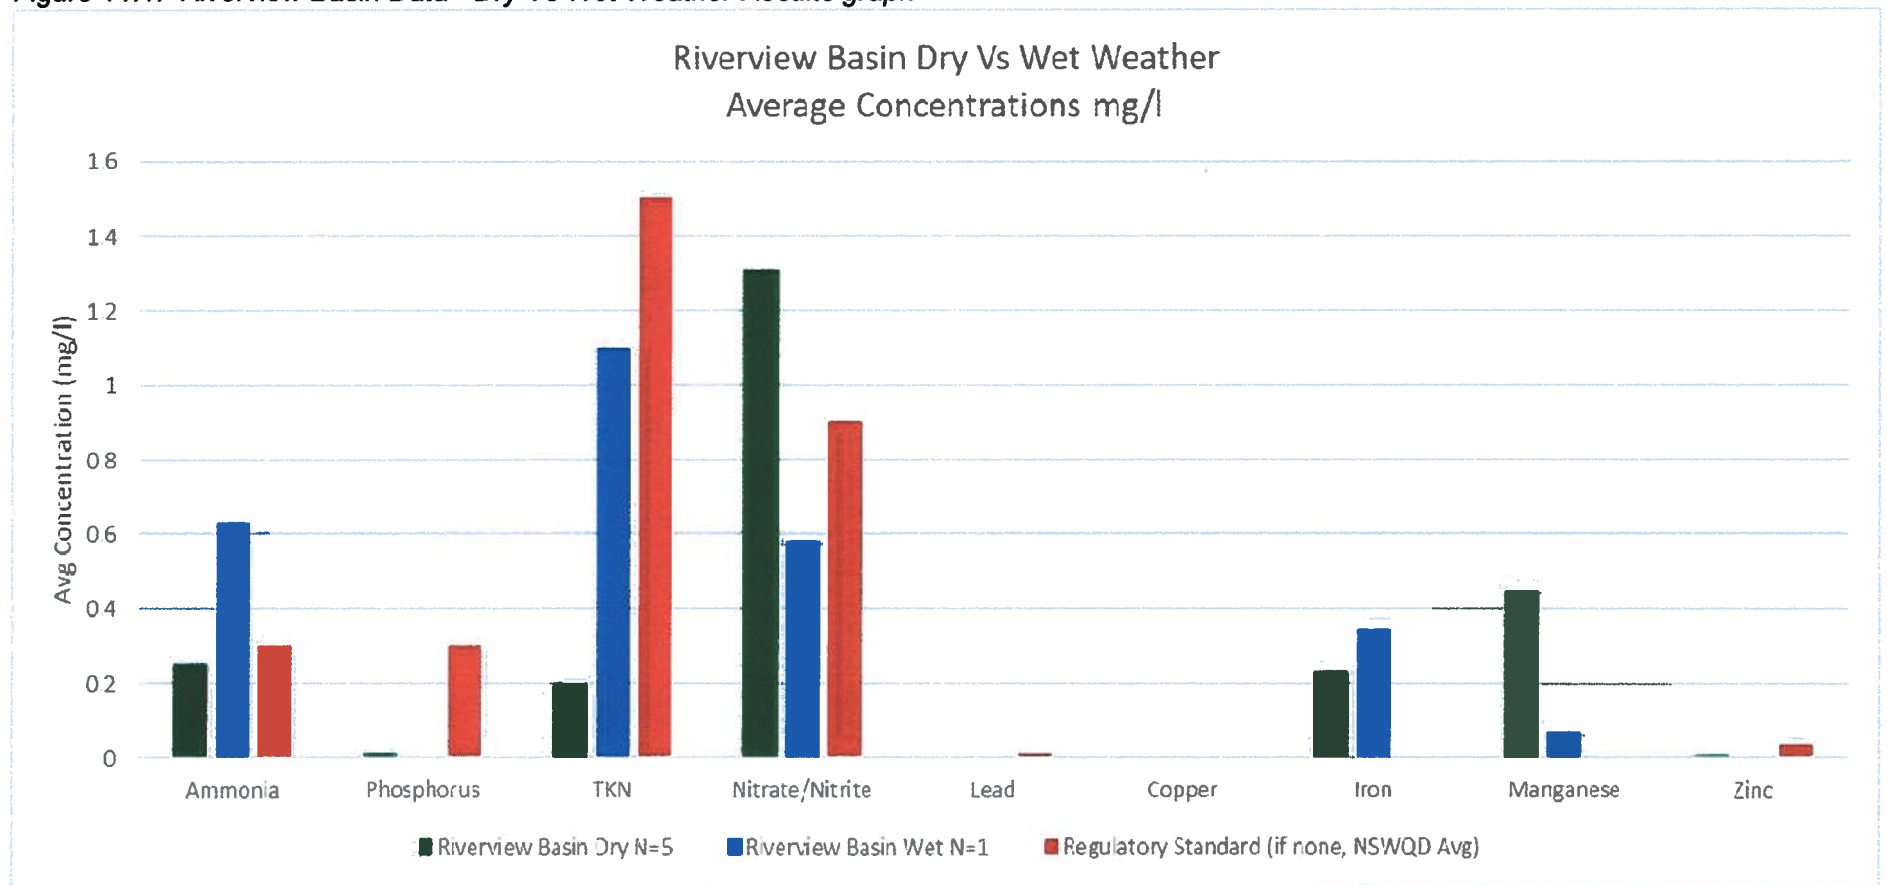
Figure 11.1: Riverview Basin Data - Dry Vs Wet Weather Results graph

Data suggest that the stream is in fairly good condition. One sample indicates that the nitrate/nitrite level in the stream exceeded the average levels for streams, all others were within normal range (Table 11.1). Wet weather vs dry weather sampling averages also suggest that Riverview basin has little water quality issues (Figure 11.1)
