STORMWATER MANAGEMENT

NORTH AUGUSTA STREAM WATER QUALITY BASELINE ASSESSMENT

June 2007

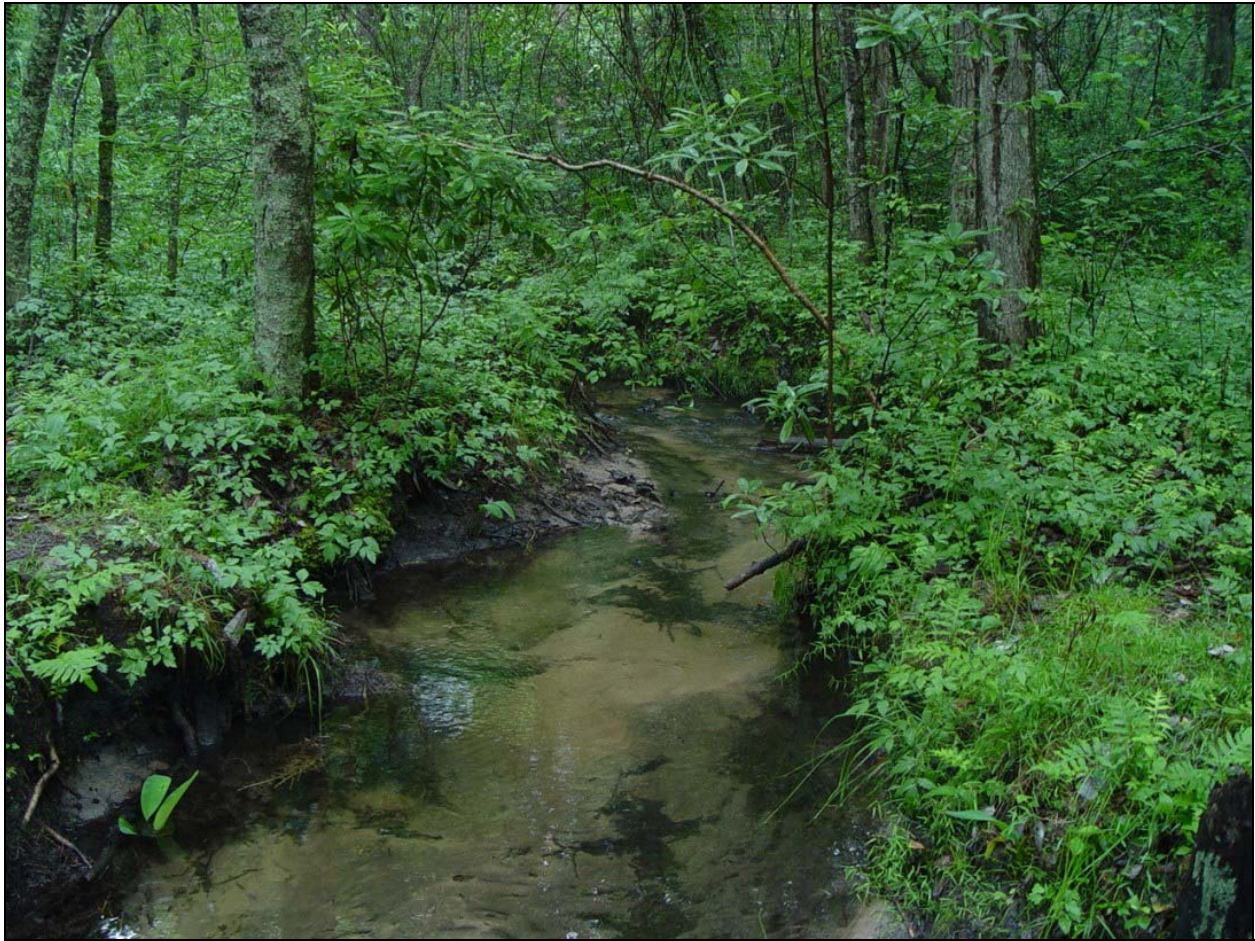
The Mims Branch basin drains a large undeveloped area located off of Highway 25 from Ascauga Lake Road to Blanchard Road and is bordered by Old Sudlow Lake Road. It is the only basin in the city that is nearly 100% undeveloped. The basin contains a perennial stream that is fed by groundwater percolation from an area located on the tract of land known as the Blanchard Tract. The basin was routinely sampled at Old Sudlow Lake Road where it leaves the city limits. In addition to this location, two other sample locations are currently being assessed to get an overall indication of stream and habitat quality.

At the present time, this basin is considered a “representative basin” since it is in a relatively undeveloped area and is not impacted by industrial, commercial or residential use. Data collected from this location can be considered representative of undeveloped conditions. Based on this, the stream water quality of this basin can be considered a target or goal for other streams located in the watershed. The basin is being sampled

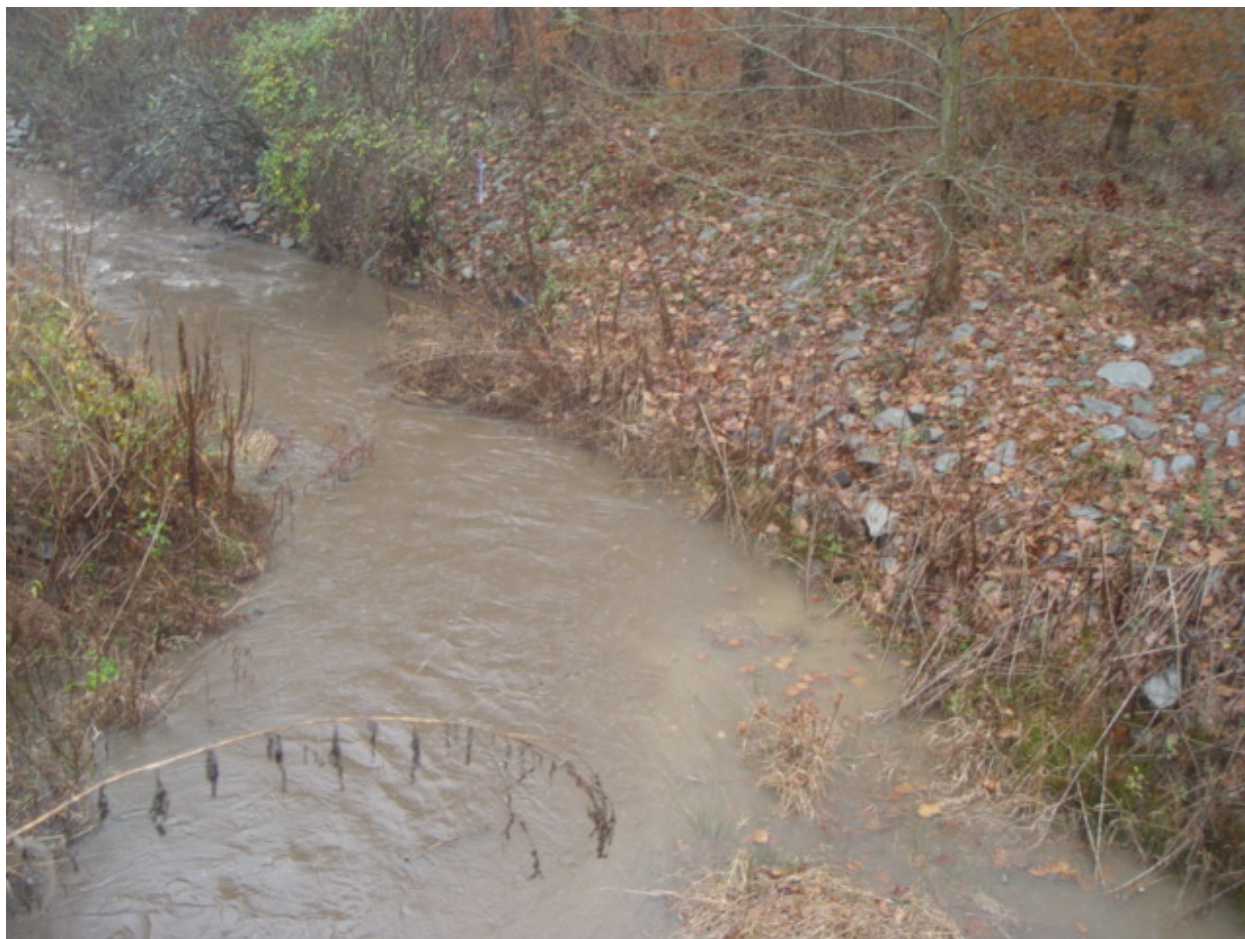
Fox Creek Basin

This basin is located at the edge of the city near the Edgefield County line. All creeks and streams that flow into Gregory Lake located on Gregory Lake Road are part of the Fox Creek Basin. Most of this area is outside the city limits. The basin does converge with Pole Branch basin within the city limits. The basin is sampled at the location just prior to its convergence with Pole Branch. Once the two basins meet, water is carried directly to the Savannah River along the undeveloped portion of Bergen Road (formerly Frontage Road) that heads toward Savannah River. There are plans for development in this area over the next few years. Currently, Bergen West development, a small commercial area, and private homes under development along Gregory Lake Road have the potential to impact Fox Creek.

The preliminary physical stream assessment at Fox Creek (observed at Martintown Road just before its confluence with Pole Branch) indicates that this stream channel is currently effective at transporting stormwater during light or heavy storm events. The assessment conducted along the stream channel resulted in a good condition rating scoring 7.7. Ample cover and substrate is present. Observations included notes of abundant aquatic plant and animal life at the stream. Bank stability at this section of the stream appeared sound. Sediment deposition was not obvious. Fallen logs and other natural debris provided suitable habitat for macroinvertebrates, although no assessment was conducted for these aquatic insects.

Water quality sampling results indicate that nitrogen concentrations in the stream were high during one sample event. The high nitrate level that was observed is inconclusive. All other sample results compared with data in Table 21 indicate that pollutant concentrations are at or below the average or standards set for freshwater streams. Water quality at Fox Creek is currently not a concern. Further sampling during rain events will be conducted to determine if nitrates are a true concern for this stream.

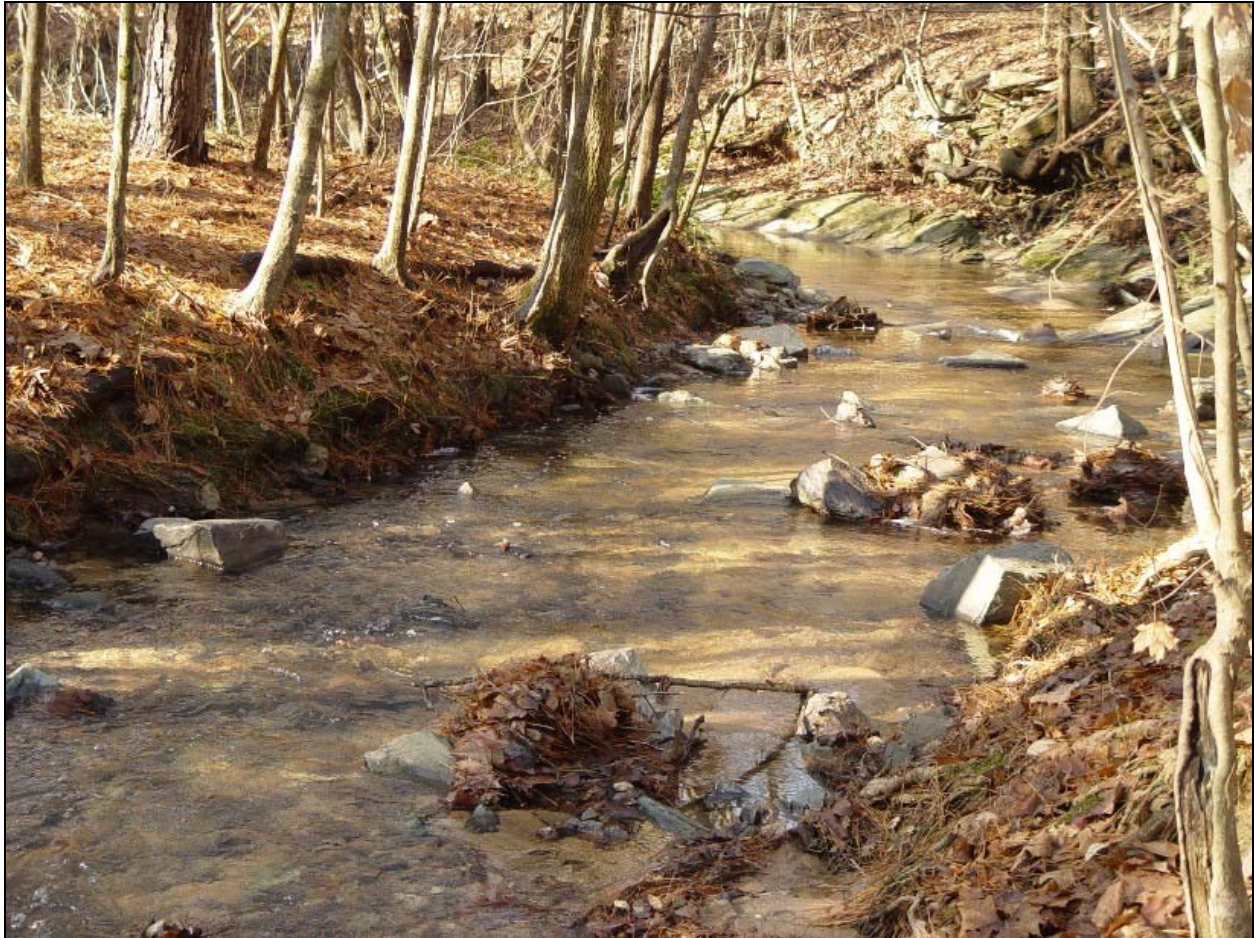
Pretty Run Basin (aka Rapids Basin)

The basin called the Rapids Basin on Figure 1 contains a stream system named Pretty Run Creek. A smaller basin just below the Rapids Basin is called Pretty Run. The Pretty Run Basin does not contain any of the stream system related to Pretty Run Creek although a road by that name exists in that part of the city. Due to the stream system and the study that will be required in the basin, the name of these basins will be changed. For this report, we will refer to both of these basins as one called the Pretty Run Basin. Updated maps of the city's basins will reflect the changes and separate names will be given to identify these two distinct basins.

Pretty Run basin is located in a highly dense residential part of North Augusta. The preliminary physical stream assessments at two reaches of the stream indicate that this stream channel is currently not effective at transporting current loads of stormwater during heavy storm events. The two assessments that were conducted along the stream channel resulted in poor conditions, scoring less than 6.0 on both. Channel erosion is evident, and the banks frequently overtop in some locations during heavy storms. In addition, bank flooding has been reported and observed at the lower reaches and middle reaches of the channel along Bunting Drive and River Bluff Road. Sediment deposition and bank instability is evident at both locations causing hydrologic alteration and channel widening. Water appearance during storm events is very cloudy and sometimes an odor is present. Upstream construction sites that are not well maintained have impacted the channel. A main sewer line runs along and in the stream channel and some of its tributaries. Overtopping of banks is obvious in several locations and manholes present in those locations may overflow if surcharging occurs.

well maintained lawns in many instances. In addition, animals are penned at or near the creek along most of its reach. The city will continue to reach out to residents in the area to provide information that may help reduce pollutant loads. Most of the fecal coliform testing in 2006 – 2007 are well below the state standard of 400 cfu/100ml. Only one event has exceeded the standard on May 14, 2007. More testing is planned in the creek during rain events. Overall sampling results indicate that the basin water quality in Pretty Run Basin is low. Nutrient loads are higher than standards, averages, and stormwater comparison data in Table 21. The city is continuing investigation of this basin. We have conducted IR studies, smoke testing, and field observations of sewer lines. No problems have been identified to date. Based on this assessment, it appears that urban runoff is the primary cause for fecal coliform exceedences in Pretty Run creek. Studies and outreach activities will continue.

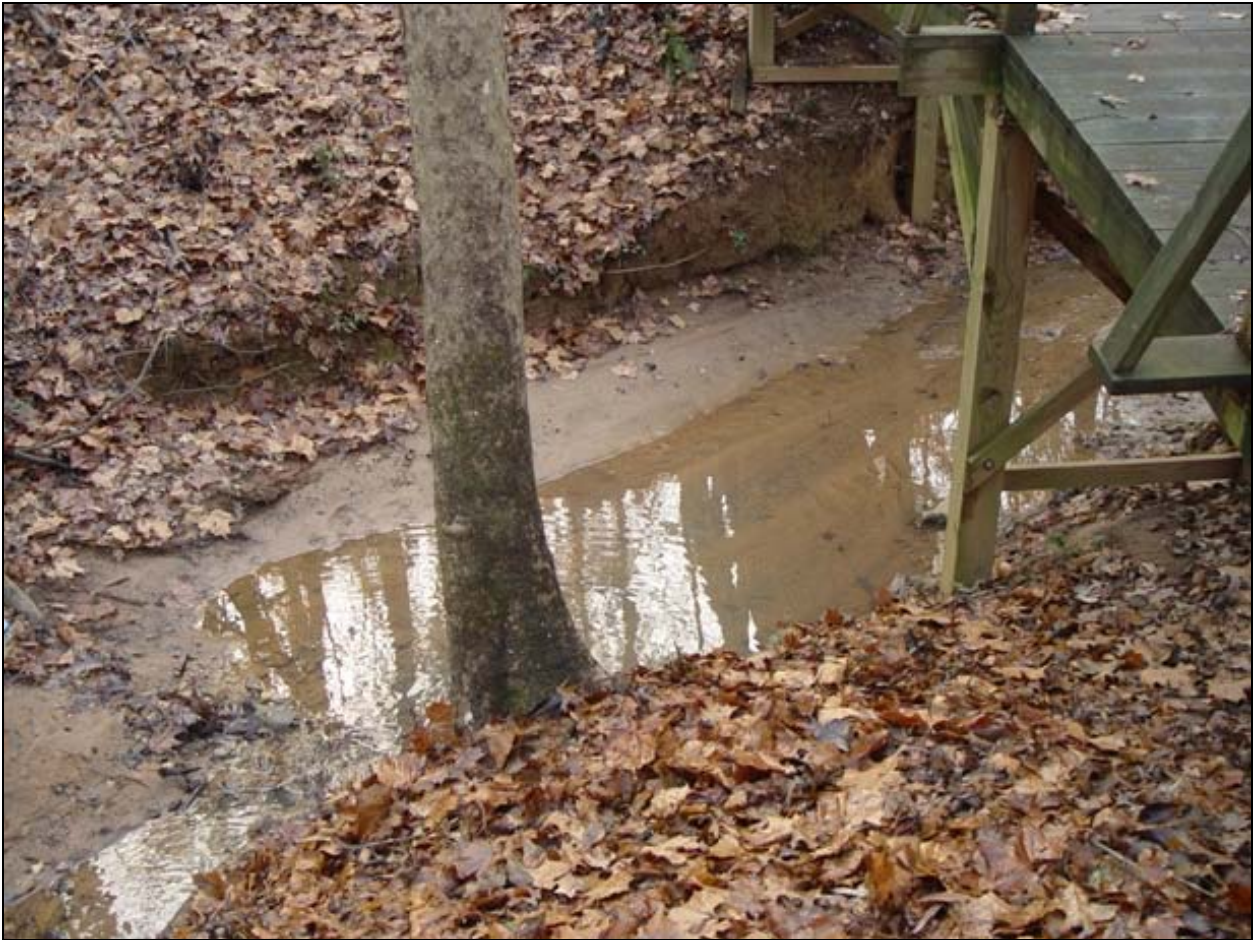
River Bluff Basin

This basin is the area just below the ridge of SC Department of Natural Resources (SCDNR) Bluffs Heritage Preserve in North Augusta near Old Plantation Road. The basin collects stormwater from the Savannah Barony Subdivision and parts of the Rapids and Herron Cove area where the land ridge slopes back toward this basin. The city monitors this basin at the end of Shoals Way just before the stream enters Savannah River.

The preliminary physical stream assessments at the sample location for River Bluff basin indicate that this stream channel currently is effective at transporting current loads of stormwater during heavy storm events. The small channel is slightly incised and bank stability is fair although deepening and widening at the assessment point is obvious. The assessment conducted along the lower reach of stream channel resulted in poor conditions overall scoring less than 6.0. Channel erosion is evident, and sediment deposition in the channel was observed. This is a low density large lot residential area of the city with some development ongoing. Upstream construction sites in Savannah Barony II and in Savannah Barony I have impacted this channel. During heavy storm events, sediment and channel substrate is washed to the river. Increased development in this area might create unfavorable conditions since the channel is relatively small throughout the entire reach of the creek bed. Adequate installation and maintenance of BMPs within the developing area will prevent further degradation of the channel in the future.

The results of the limited sampling at this time show no real concerns regarding pollutants. Overall sampling results indicate that this basin water quality is in good condition.

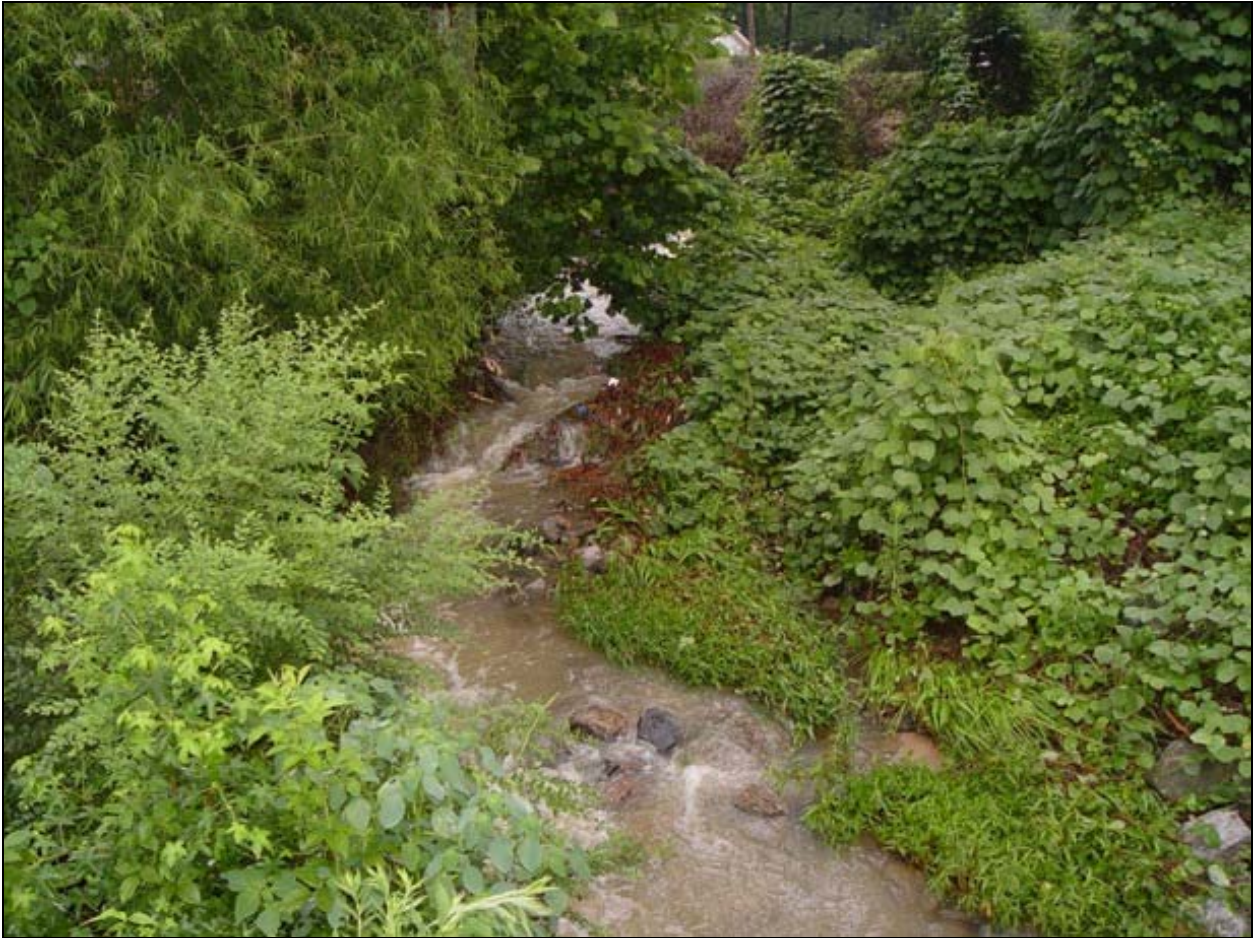
Waterworks Basin

The Waterworks basin is a very large basin in the city that handles tremendous flows during rain events. Flows from this basin incorporate stormwater from residential and higher density commercial entities throughout the area. The basin enters the river through two separate channels within the River Golf Club.

The city, along with the University of South Carolina at Aiken, have been working together to study the water quality in this basin. Currently, the city is implementing a capital improvement project of storm sewers and roads to eliminate the flooding problems that occur during heavy rainfalls. The stormsewer infrastructure at Buena Vista Avenue is currently being replaced with larger culverts and additional piping to help support the current volume of stormwater during heavy rain events. The improved infrastructure will improve conditions and are intended to alleviate flooding problems along Buena Vista Avenue near the Mealing Road communities and the Edenfield Park area that routinely occur and disrupt traffic flow. Figures 2 and 3 depict a typical flooding event that occurs at this location.

Overall sampling results indicate that the water quality at the outfall of this basin (below the River Golf Club ponds) is good. At reaches farther up in the channel prior to the River Golf Club, sampling results indicate higher levels of pollutants. During storm events, the data shows increased levels of pollutants making it to the river. The wetlands remove many of the solids during heavy rain events as indicated by the turbidity results dropping from 325 NTUs to 49 NTUs during the rain event that occurred in August 2006. That being said, the nutrient loads and metal loads were not reduced to lower levels in all cases. The ammonia and lead level increased with the 24 hour composite sample. Other constituents dropped from elevated levels to acceptable levels. This data suggest that while the Water Works Basin is transporting higher levels of pollution during rain events, much of it is filtered out as it passes through the wetland ponds at River Golf Club, but not entirely. During routine sampling and dry weather, the ponds work well at filtering pollutants. Early study results from USC-Aiken researchers, indicate the same. The city will continue to monitor the basin and implement further improvements to regain stability within the basin. In addition, it would be beneficial to initiate further discussions and plans to implement additional BMPs within the basin that will help to reduce pollutant loads during storm events.

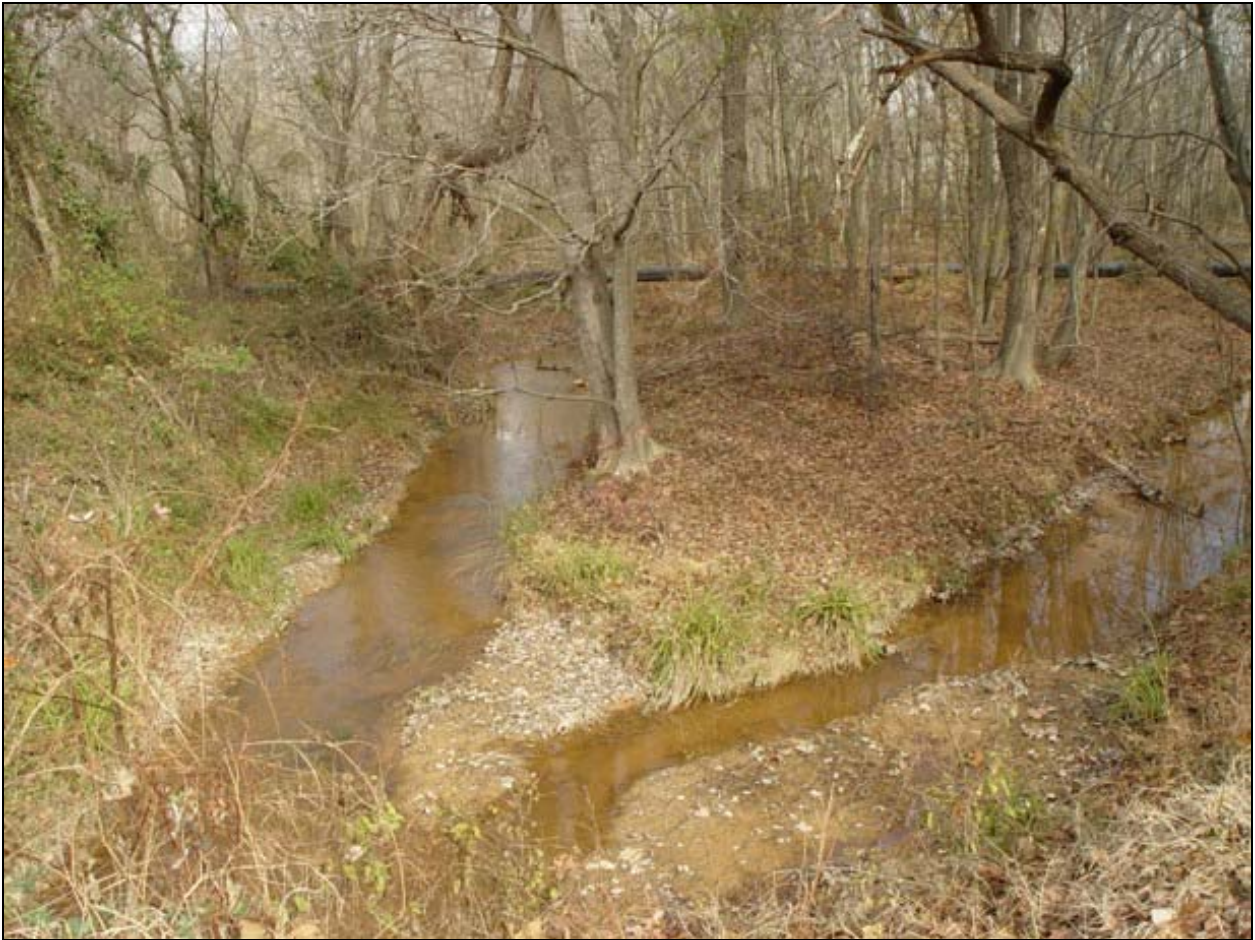
Womrath Basin

This basin includes the area located from the junction of Knox Avenue and Old Edgefield Road back to Carolina Springs/Womrath Road. The water flows from these areas and then crosses Old Aiken Road and beyond until it crosses Highway 1 (Aiken/Augusta Highway). From there the unnamed creek empties into wetlands located adjacent to Horse Creek. This basin is sampled at the TTX Plant located off of Hamburg Road.

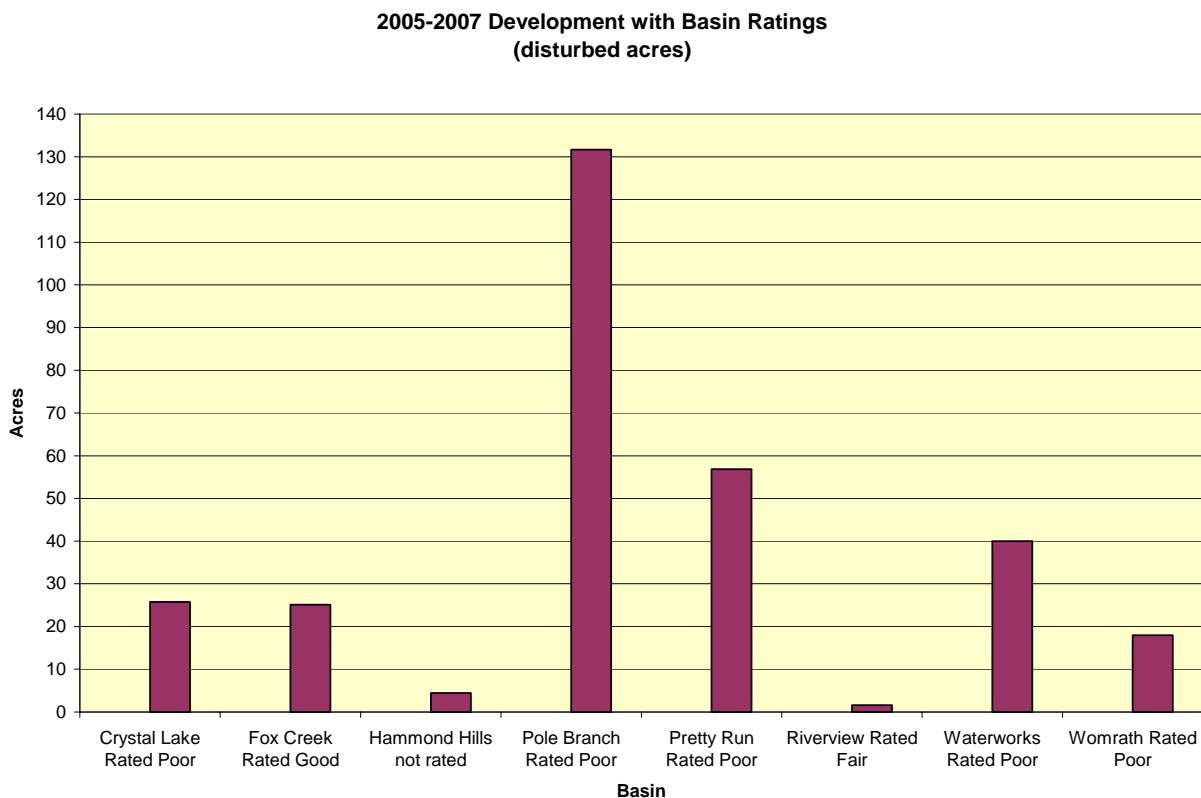
Figure 1: 2005 – 2007 Development

acres have been developed in North Augusta. Of these most of the development approximately 130 acres were developed in Pole Branch Basin and another 68 acres has been developed in Pretty Run basin (see Figure 2). These are basins that are rated poor in this initial assessment of water quality in North Augusta’s watershed. To help offset the impact to water quality from these developments, the city has a water quality requirement for new developments. All development projects greater than one acre must treat the first one inch of rainfall prior to it leaving the site. Many of the projects are using small wetland forebays in their stormwater detention ponds, and others are installing underground stormwater treatment devices. These measures will ensure that the runoff from development projects will be treated prior to its release into local streams.
